Integration of Remote Sensing and Risk Analysis for Airframe Structural Integrity Assessment

D. Cope¹, J. Cronenberger¹, K. Kozak¹, K. Schrader¹,
L. Smith¹, and C. Thwing¹

¹ Southwest Research Institute, San Antonio, Texas, 78238, USA

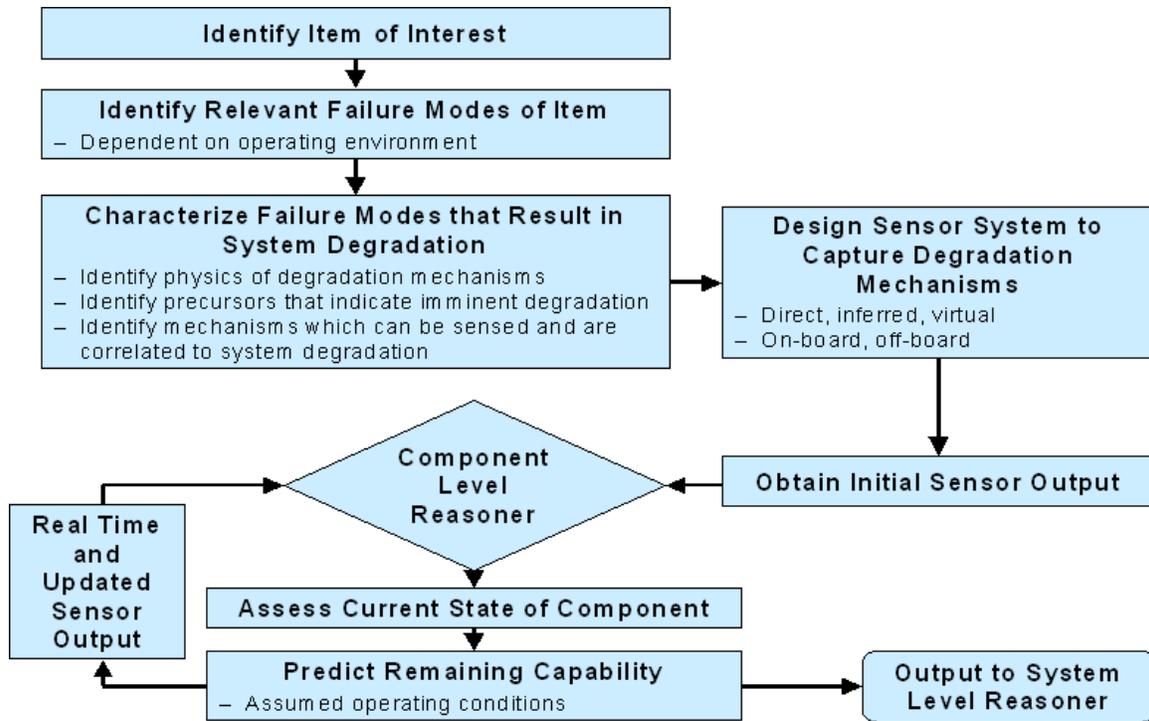
Figure 2: Development Process for a Structural Health and Integrity Monitoring (SHIM) System

As illustrated in Figure 2, the development for a SHIM system involves the following process (Derriso, 2008).

- Identify the item of interest and its relevant failure modes
- Characterize the critical failure modes that result in system degradation
- Design a sensor system to capture degradation mechanisms
- Develop a component level reasoner to assess the current state of the component based on initial sensor output along with real-time and updated sensor output
- Predict remaining structural capability based on interpretation of sensor data and assumed operating conditions
- Output component assessment to a system level reasoner

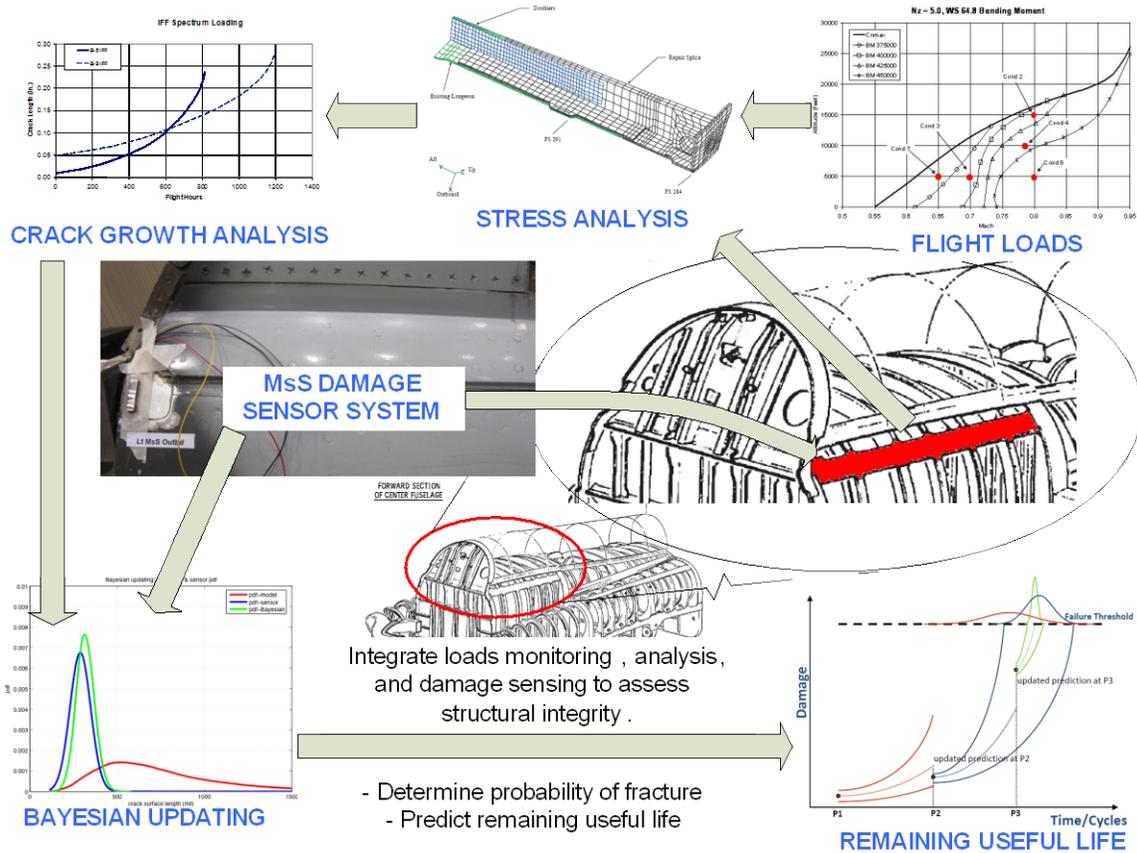
Figure 3: Technical Approach for Developing an Integrated Airframe Structural Health and Integrity Monitoring (SHIM) System

Following the SHIM development process, the internal R&D project involved the following primary tasks.

- Characterization of fatigue cracking, the primary failure mode in the upper longeron
- Design of a damage sensor system to capture degradation mechanisms
- Development of a component level reasoner to integrate damage sensor data with structural loads data and failure analyses in order to assess the current state of the component and predict the remaining capability
- Component testing of the system design in order to demonstrate the feasibility of the SHIM system
- Validation and assessment of the system design

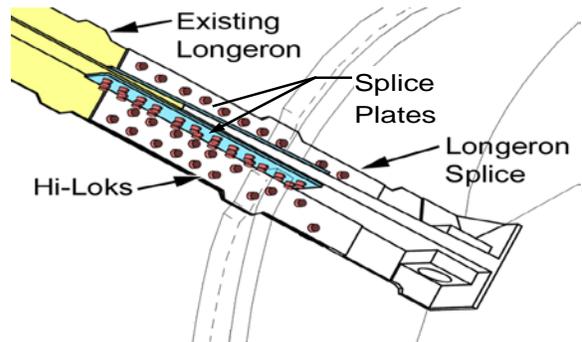
Figure 4: Splice Repair of Upper Longeron

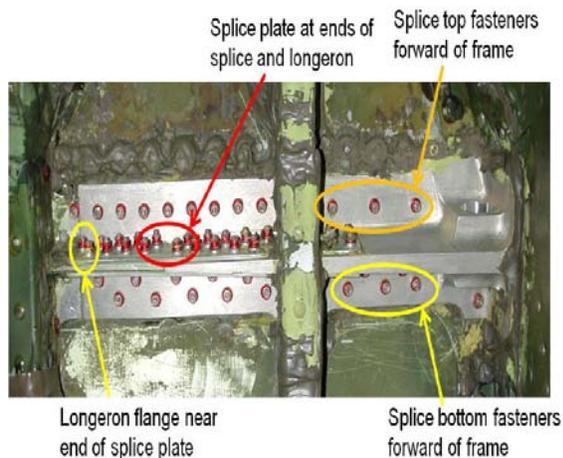
Figure 5: Critical Failure Locations on Upper Longeron

Figure 5 shows the critical fastener locations identified through the probabilistic risk assessment on the actual longeron splice on the fatigue test article. This assessment confirmed the two FCLs (in the flanges of the longeron splice and in the splice plates)

determined from the DTAs and full-scale fuselage fatigue tests. It also identified a third critical location in the existing longeron at the aft end of the splice plate, which was also identified in the full-scale fuselage fatigue test. A fracture mechanics model of this location was not available during the project in order to include it in the research. The structural system reliability analysis allowed researchers to determine specific locations in the joint where emerging sensor technology, such as the MsS technology developed by SwRI, could be incorporated into the design of a monitoring system for detecting, localizing, and assessing damage in the upper longeron.

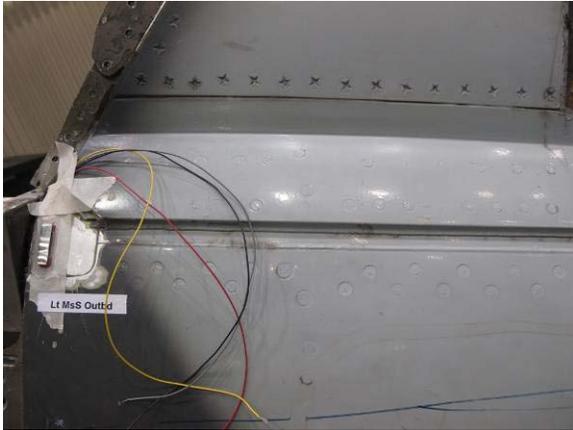
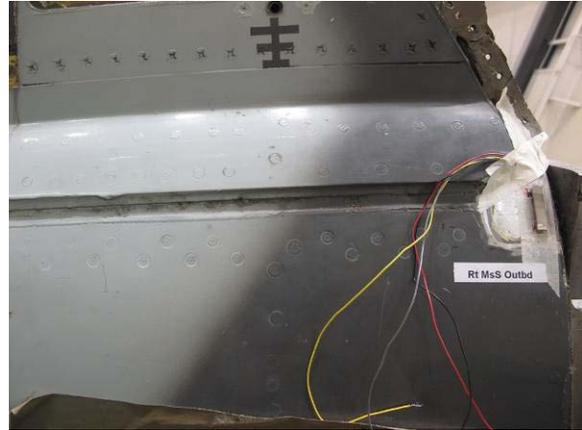
a) Lt MsS Outbd

b) Rt MsS Outbd

Figure 6: Sensor Locations on Exterior Surface of Upper Longeron

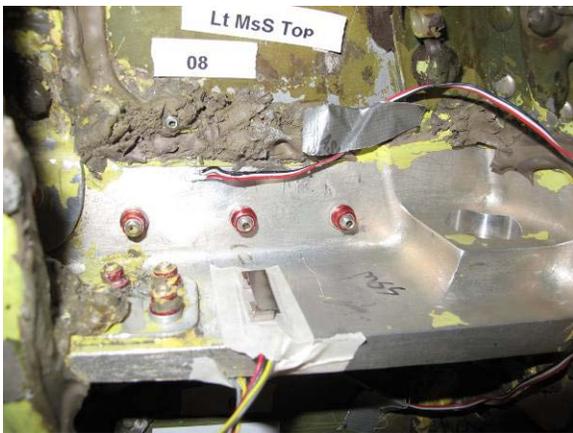
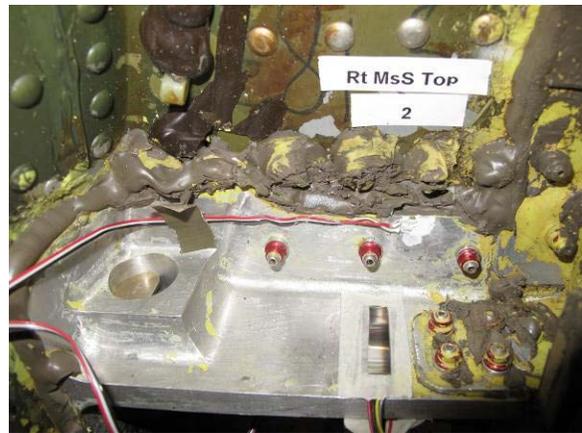
a) Lt MsS Top

b) Rt MsS Top

Figure 7: Sensor Locations on Upper Splice Plates of Upper Longeron

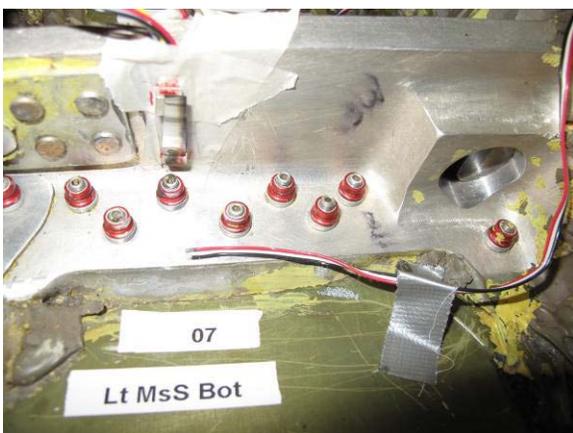
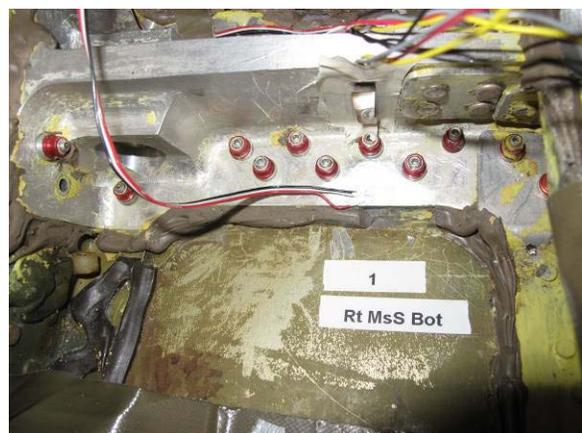
a) Lt MsS Bot

b) Rt MsS Bot

Figure 8: Sensor Locations on Lower Splice Plates of Upper Longeron

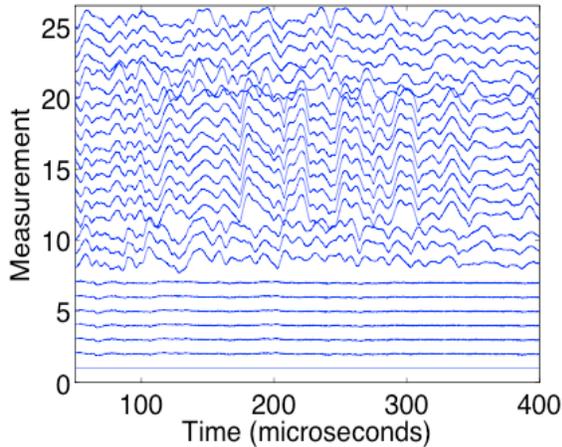
Figure 9: Waveform Data Sets from Rt MsS Top Sensor

Changes in the waveform data sets could be clearly seen in the Rt MsS Top sensor readings indicating defect reflections in the RH upper splice plates, as can be seen in Figure 9. Data collected from the Rt MsS Aft sensor also showed clear indications of crack growth in the RH longeron. Based on these sensor readings, the waveform data sets for the Rt MsS Top and Rt MsS Aft sensors were analyzed further in order to identify increases in sensor reflections that could potentially be correlated with any crack growth at these locations.

Figure 9 shows a change on the seventh waveform data set for the Rt MsS Top sensor. The measurement number of the vertical axis denotes the sequential queries (or waveform data sets) of the MsS sensor readings taken as the fatigue test progressed. These data sets were analyzed further using SwRI developed Matlab software in order to focus in on the location where the defects may be located based on the sensor readings. Figure 10 shows data that was phase shifted to match the suspected defect location in time. Reflection differences were determined by comparing each sensor reading to the baseline reading at Measurement 0. Then, each of the reflections difference was stitched to make an energy plot of the wave forms representing an accumulated plot encompassing a 5- to 11-inch region along the longeron around the suspected defect. Figure 10 shows accumulated data stitched to create an energy plot of the data shown in Figure 9. The plot in Figure 10 represent a location in time that represents the possible reflected energy of a potential defect in the RH upper splice plate. The energy plot for the Rt MsS Top sensor does present a significant increase in the signal reflection, but these signals may also not be concrete evidence of crack detection and monitoring. Examination suggests that the noise associated with

each data set is attributed to a change in the magnetic bias field of each sensor itself and not of the specimen. This change may be due to possible shifting of the magnets that were attached to each sensor during large deflections of the structure due to the applied cyclic test loads.

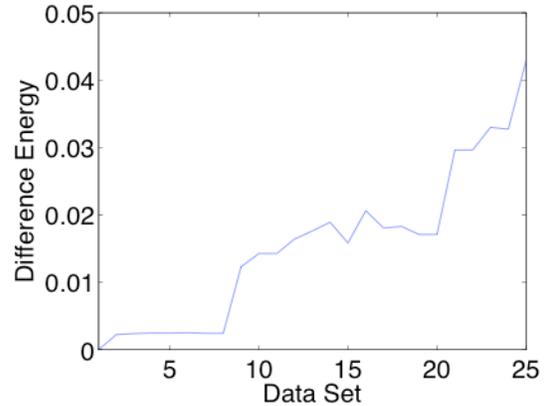
Figure 10: Energy Plot Rt MsS Top Sensor

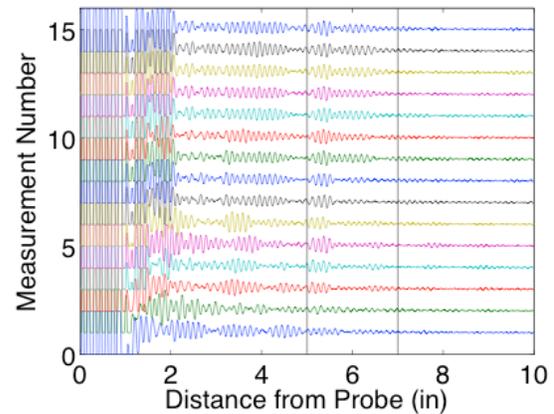
Figure 11: Waveform Data Sets from Rt MsS Aft Sensor

Sensor readings collected from the Rt MsS Aft sensor are shown in Figure 11. Noting the horizontal axis is the distance from the probe and the signal fluctuations along this direction, clearly a reflection can be seen at approximately five inches from the sensor. This reflection slightly increases from one data set to another, and it is believed to be the signal from the crack in the RH longeron flange as the crack increases in size during testing. Figure 12 shows a close up view of the reflected energy window and the change in signal response from one query sample to another as data was accumulated. Figure 13 shows the energy responses for the area of interest in Figure 12 as the data was accumulated over time from the aft sensor. As expected, it shows a monotonically increase in energy amplitude from query to query.

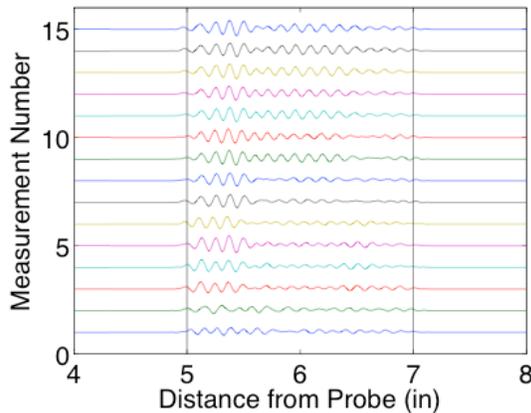
Figure 12: Close-up of Reflected Energy from Rt MsS Aft Sensor

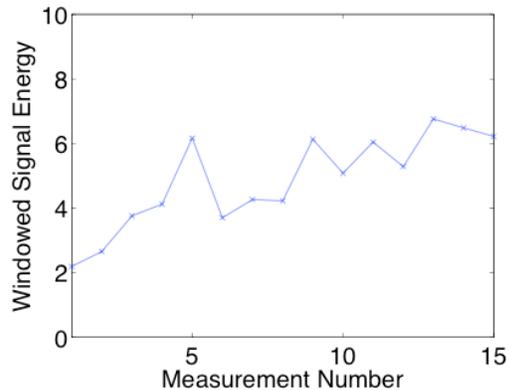
Figure 13: Energy Plot Rt MsS Aft Sensor

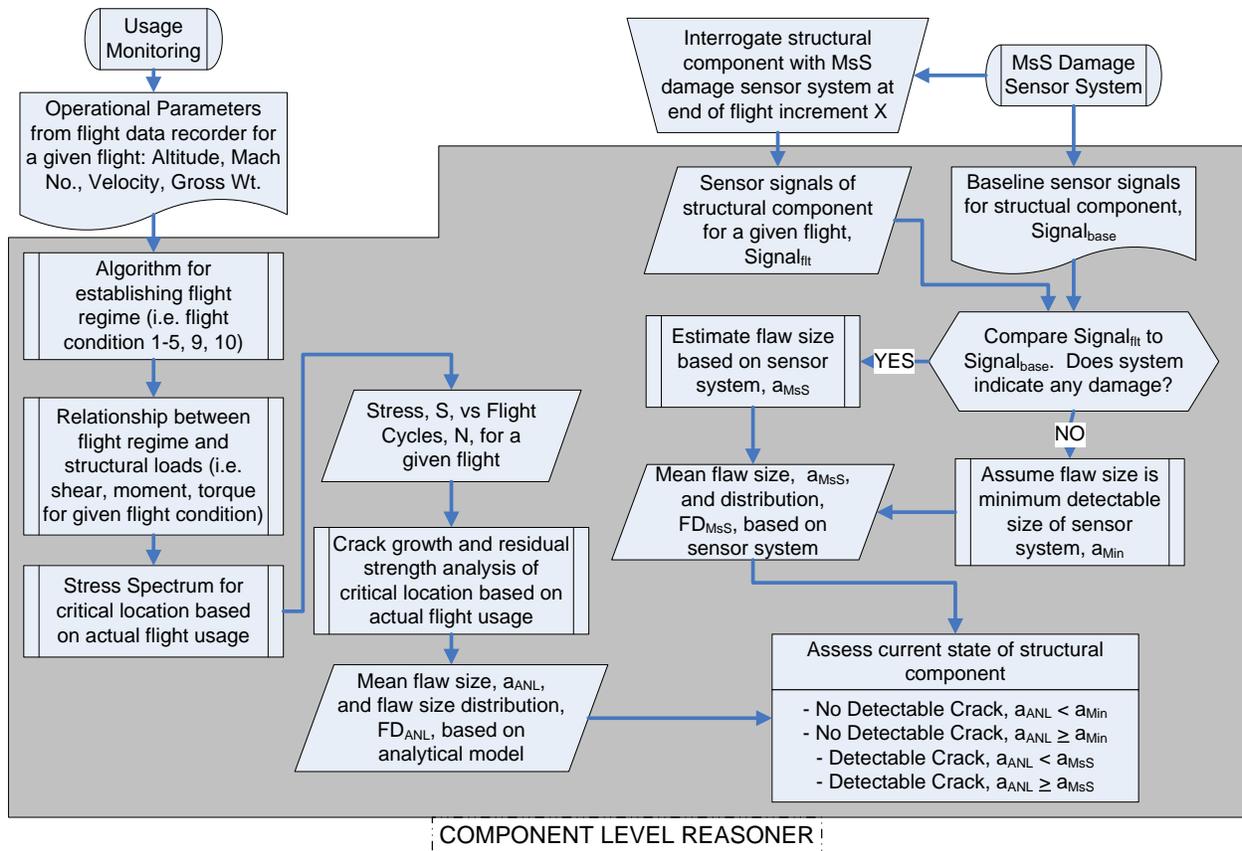
Figure 14: Logic Tree for Component Level Reasoner

The logic tree is composed of three main sections – one section for usage monitoring, another section for the damage sensor system, and the third section for integrating the analysis and sensor data with intelligent reasoning logic and algorithms for assessing the current state of the structural component. The usage monitoring section (left portion of the flowchart in Figure 14) includes algorithms for establishing flight regime, determining the stress spectrum for critical locations based on actual flight loads, and performing crack growth analyses of critical locations under actual usage. In the reasoning process, this usage monitoring provides the analyst with the predicted state that flaws in the critical areas should be in based on the measured or actual flight usage.

In the section for the damage sensor system (right portion of the flowchart in Figure 14), Boolean logic is used to determine if a flaw is detected, and if so, a flaw size distribution is estimated based on correlation of signal amplitude to damage size at critical locations. As discussed in Section 6 of this paper, this correlation was determined from fatigue testing of the structural component with a prototype MsS damage sensor system used to monitor the component during the testing. The damage sensor system provides the most likely state of flaws in the critical areas, which the analyst uses with the predicted state of flaws in the reasoning process in order to assess the component's health and integrity.

The assessment section (box illustrated in the lower right corner of Figure 14) integrates the analysis and sensor data to estimate the flaw size distribution in the component. Then, based on this estimated flaw size distribution and assumed future operating conditions, the remaining useful life and likelihood of structural failure are computed for the structural component. The reasoning process for the structural health and integrity assessment is described in the following paragraphs.

The component-level reasoning process described in Figure 14 consists of two separate methods of estimating the size of a crack/flaw – one method based on actual usage and crack growth analyses, another method based on sensor signals and correlation of signal amplitude to known flaw size. To rectify the differences in these estimates, which are certain to exist, probabilistic methods can be applied. Before going into detail on the methods, it is important to point out that these methods, while powerful, are predicated on the ability to accurately assess uncertainty of the individual estimating processes. Poor uncertainty estimates for either method will tend to lead to non-optimal combined estimates and may ultimately lead to misleading results. In particular, overestimating the accuracy of either estimate may bias the combined results strongly toward that estimate.

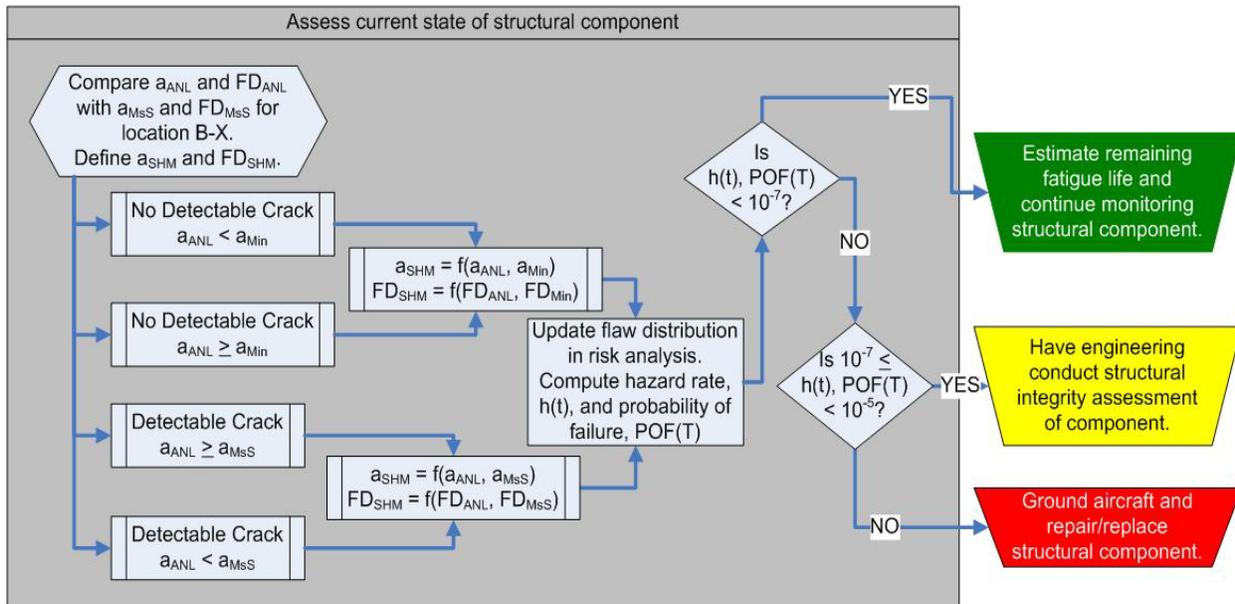
Figure 15: Reasoning Logic Tree for Structural Health and Integrity Assessment

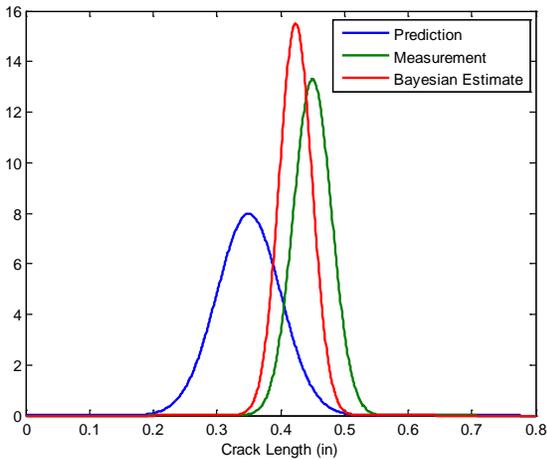
Figure 16: Iteration Example of Bayesian Estimation Process for Gaussian Distributions

For example, suppose the predicted crack size distribution has a mean of 0.35-inch and a standard deviation of 0.05-inch, while the measurement distribution has a mean of 0.45-inch and a standard deviation of 0.03-inch. Figure 16 shows these distributions along with the resulting Bayesian estimated crack length distribution, which illustrates how the estimate has a higher certainty than either the prediction or the measurement alone.

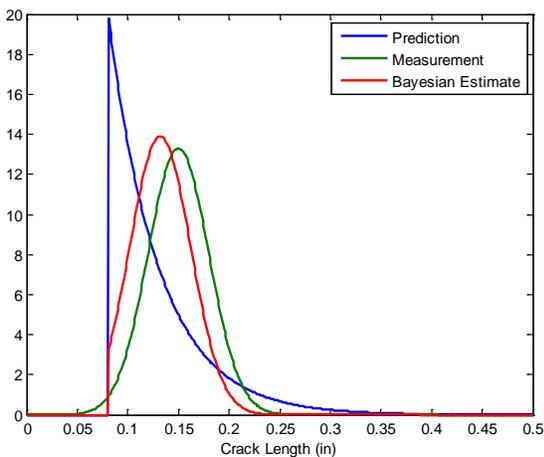
Figure 17: Iteration Example of Bayesian Estimation Process with a Non-Gaussian Distribution

For non-Gaussian distributions, which are more typical for this type of application, the underlying process is the same, but computation of the resultant distributions must typically be done numerically. Figure 17 provides an example of the estimation applied to a prediction that is non-Gaussian and a measurement that is Gaussian. The resultant distribution is non-Gaussian.

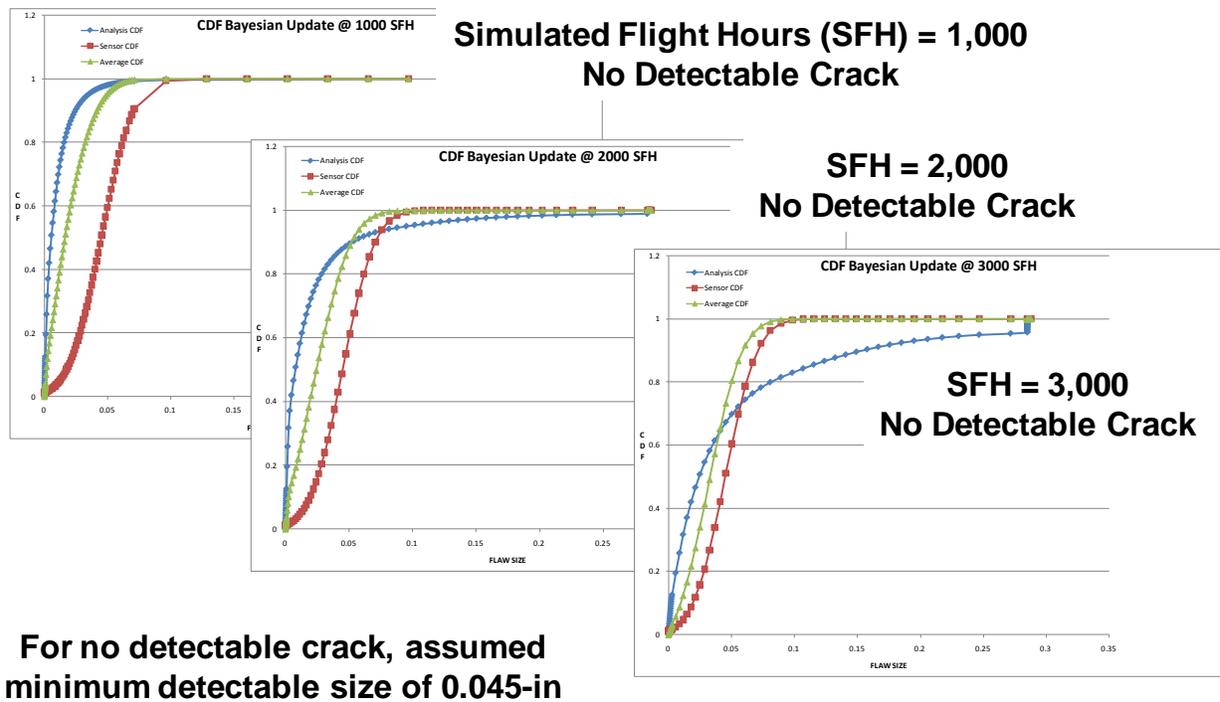
Figure 18: Fusing Sensor Signals and Analytical Crack Growth Using Bayesian Updating

2007). Figure 18 shows an example of how Bayesian principles are used to integrate sensor signals with crack growth analyses for the upper longeron. At given number of operational flight hours, the analytical crack growth model provides a cumulative density function (CDF) of the flaw size based on actual usage. Data from the damage sensor system also provides a CDF based on the signal amplitude of the sensor. Using Bayesian principles, these two CDF's are updated into one CDF estimating the flaw size distribution. This final estimate is based on a weighted average of both the analysis and sensor information. In this example, the flaw is below the minimum detectable level of the sensor so for the Sensor CDF, it is assumed that the flaw size is at the minimum detectable level of 0.045-inch with a wide range in the flaw size distribution (variance of 0.0004-inch^2). Initially, with a fewer number of flight hours, the crack growth analysis predicts a relatively small flaw size distribution so the Average CDF favors the Analysis CDF. As the flight hours increase, the Analysis CDF increases, and eventually, the crack growth analysis predicts possible fatigue failure of the component. However, the Sensor CDF remains the same since the sensor has not detected a flaw. Therefore, the Average CDF favors the Sensor CDF. Utilizing the Average CDF to estimate the flaw size allows for a more accurate prediction of the

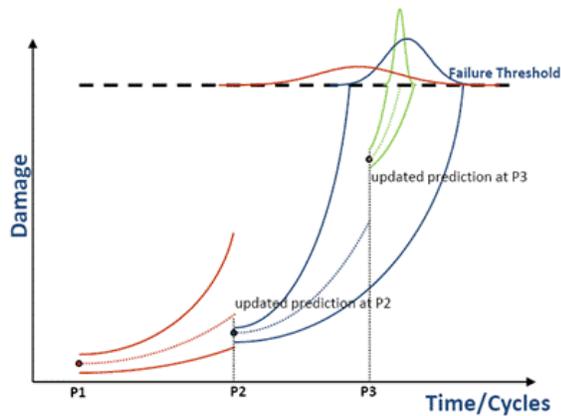
Figure 19: Prediction of Remaining Useful Life Based on Updated Flaw Size Distribution

Updated flaw size distributions can be used to compute conditional failure rates and remaining useful life, as illustrated in Figure 19. The distribution of results for each of the three stages of measurements is plotted at the top of the graph at the damage level defined as the failure threshold. These distribution plots illustrate how the predictions tighten up as more information is measured. Initially (point P1), analysis predicts sufficient remaining useful life with a low probability of structural failure, but the life prediction varies widely. As the life prediction is updated with the Average CDF (point P2), the range in life prediction tightens, and the likelihood of structural failure increases. As the component reaches the end of its useful life (point P3), the range in life prediction narrows, and the likelihood of structural failure reaches unacceptable levels. Each update is based on a weighted average of the flaw size distribution from the sensor data and crack growth analyses, instead of solely relying on either the sensor or the analyses. Using the weighted average CDF provides an improved estimate of the remaining useful life and probability of structural failure.

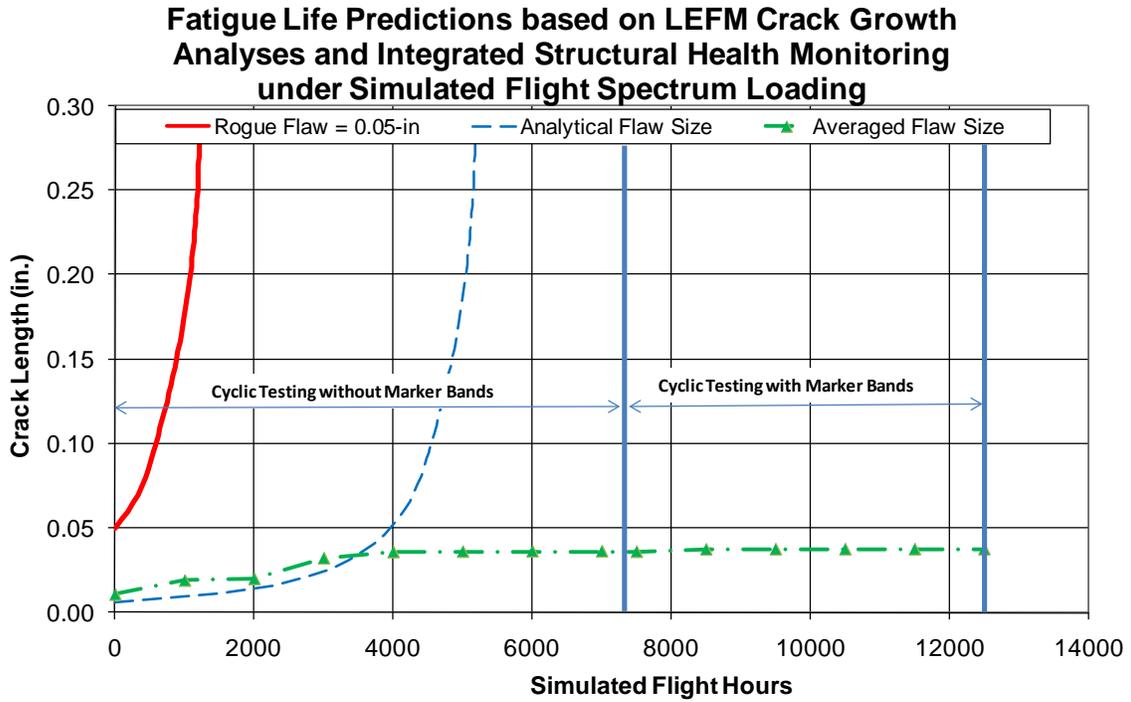
Figure 20: Fatigue Life Prediction of Upper Longeron Splice Plates

Figure 20 shows the crack growth life predictions for the splice plates of the upper longeron utilizing three different methods. The first method is the conventional DTA methodology described in Section 2.1, which starts with a rogue flaw of 0.05-inch and has a fatigue life of only 1,215 simulated flight hours (SFHs). The second life prediction starts with an initial flaw size distribution for 7075-T6 plate (obtained from the literature) that has a mean flaw size of 0.0061-inch. With this initial flaw size, the fatigue life prediction is 5,174 SFHs based on LEFM and the actual spectrum loads applied during the fatigue test. The third life prediction method employs Bayesian updating to estimate the flaw size periodically during the fatigue test based on the crack growth analyses and readings from the MsS damage sensor system. During the fatigue test, spectrum flight loads were applied for 12,500 SFHs, and sensor readings were taken approximately every 250 SFHs. No crack indications were ever identified by the sensors during the SFH fatigue testing. Subsequent teardown examination confirmed that the upper longerons did not have detectable cracks during the simulated flight spectrum testing. Since the sensors did not detect any cracks, it

was assumed that any cracks in the splice plates was at the sensor's minimum detectable level of 0.045-inch, and flaw size distributions were updated accordingly at the time frame for each sensor reading. Utilizing the Bayesian updating, the averaged flaw size stayed below the minimum detectable level for the entire spectrum fatigue testing, as indicated by the green triangular assessment points plotted in Figure 20. Even though initially the averaged flaw size was larger than the analytical flaw size, the averaged flaw size never exceeded the minimum detectable level of the sensor, and the crack growth life predictions, which were updated at each interval of sensor readings, never reached critical crack length. Both of these conditions were confirmed through the fatigue testing and teardown examination.

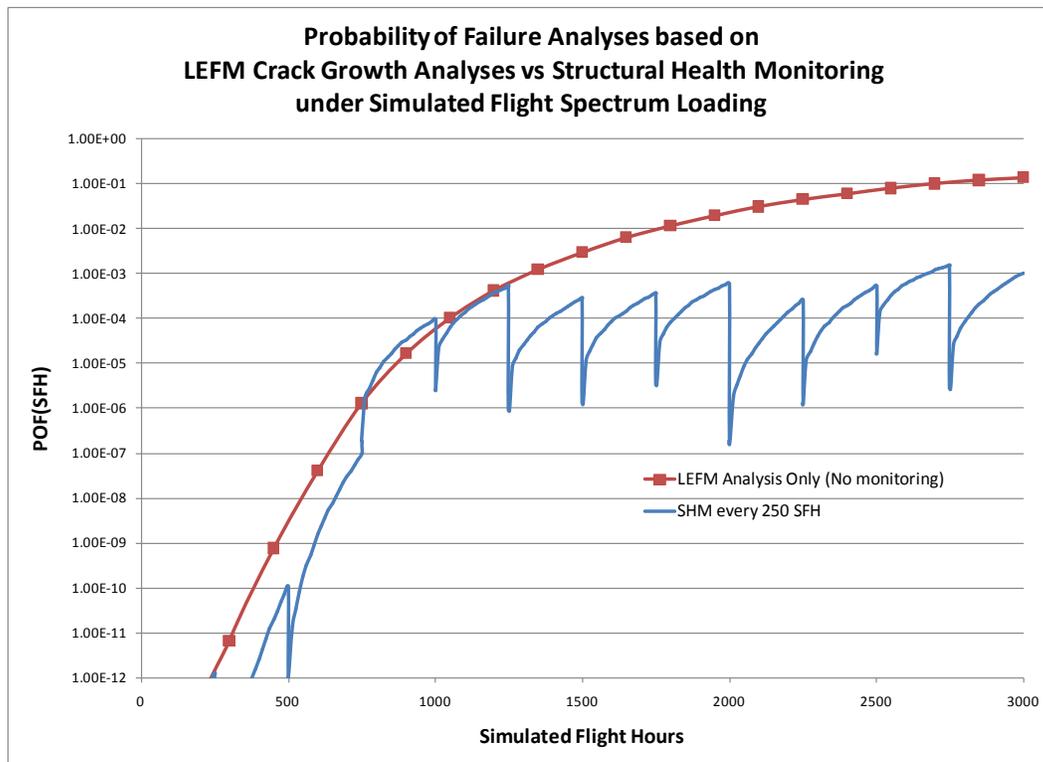
Figure 21: Probability of Failure Analyses of Upper Longeron Splice Plates

Probability of failure (POF) analyses were also performed at each interval of sensor reading using the averaged flaw size and its distribution, which was continually updated based on Bayesian principles. Figure 21 compares the POF results based solely on LEFM crack growth predictions to POF results utilizing the SHIM system. These analysis results clearly show that continual monitoring and updating the estimated flaw size with its distribution can reduce the POF by at least an order of magnitude, with the exception of one interval of 500 SFHs where the POF utilizing the SHIM system was the same as the POF based solely on analytical predictions. When the averaged flaw size reached a constant value of 0.0375-inch, just below the minimum detectable level for the sensor, the POF analyses based on the SHIM system leveled off, never increasing by more than three orders of magnitude during the monitoring interval of 250 SFHs. Using the same reasoning processes in the SHIM system, the POF could likely be reduced even further if the monitoring interval had been shortened. The analysis results in Figures 20 and 21 illustrate how predictions of remaining useful life and probability of failure assessments can be improved with continual structural health monitoring.

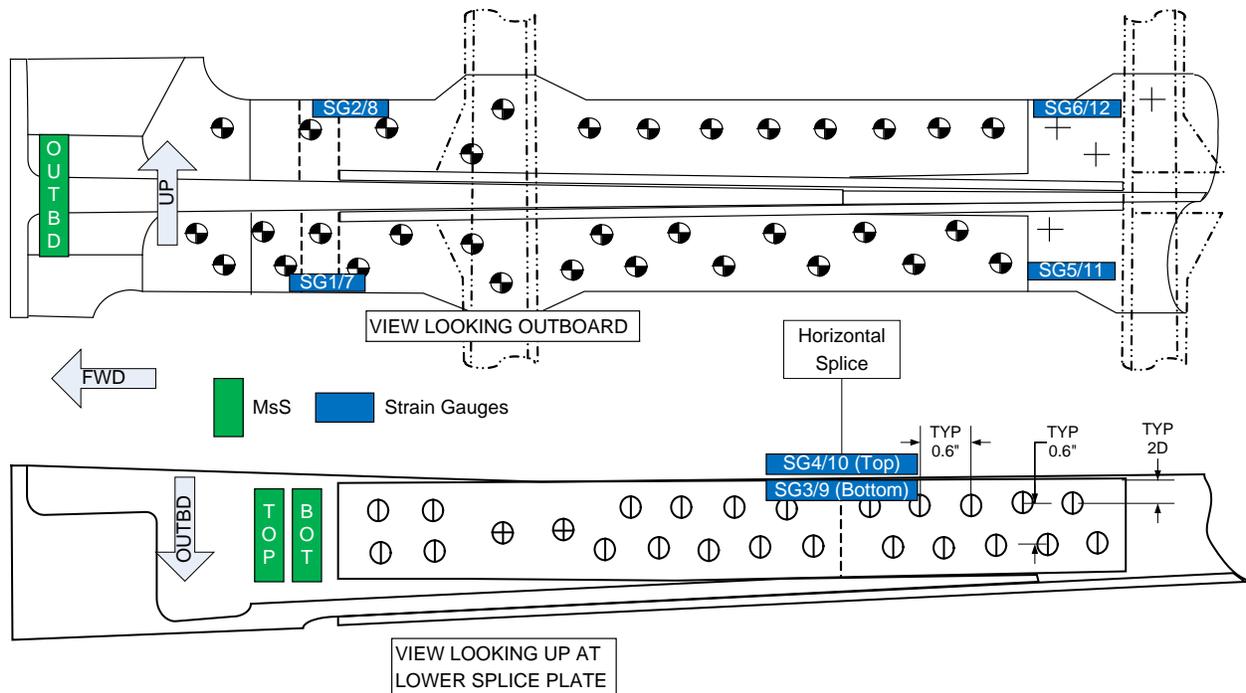
Figure 22: Strain Gauge and Sensor Locations on Longeron Splice

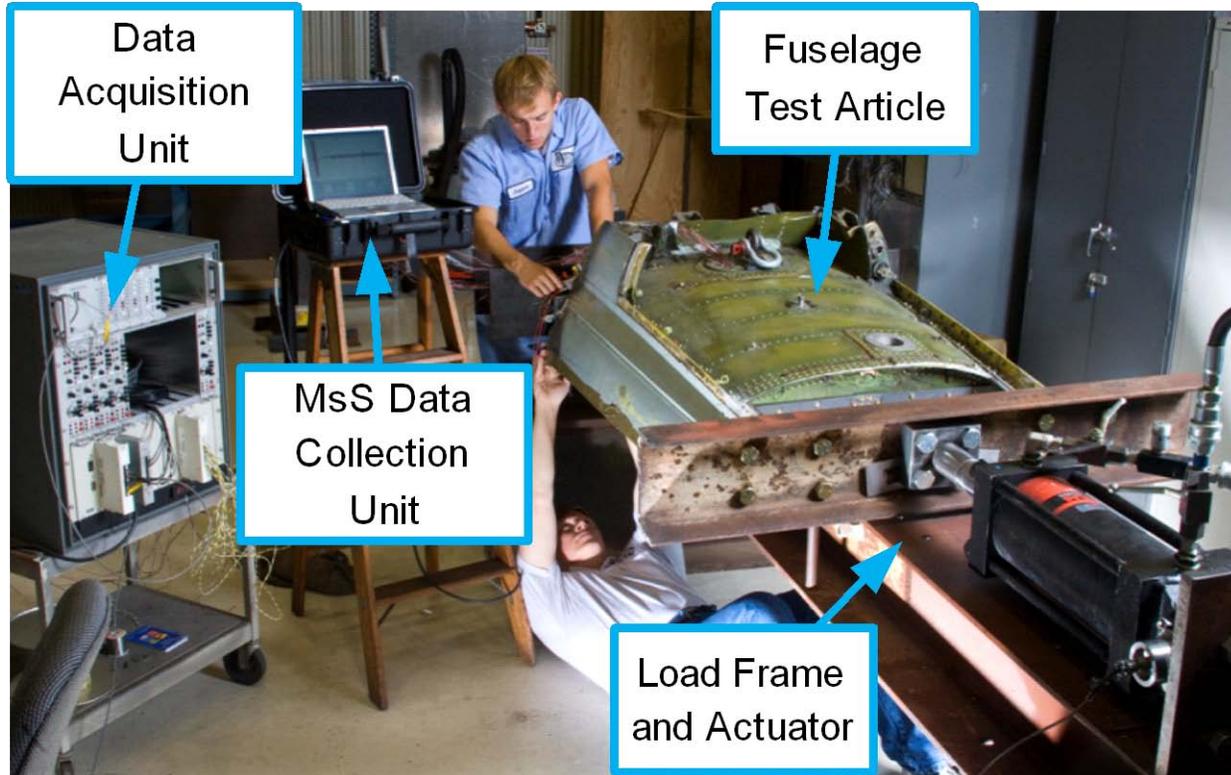
Figure 23: Fatigue Test Setup of Upper Fuselage Section

After extracting the airframe section from a condemned fuselage, technicians modified the test article and constructed a test fixture so that each upper longeron could be loaded in tension using a single load actuator. Strain gauges were installed on the test article at various locations across the upper longeron splice along with MsS sensors. As illustrated in Figure 22, strain gauges were installed on the lower and upper flanges of the longeron splice (SG1/SG2 on the RH longeron splice, SG7/SG8 on the LH longeron splice). Strain gauges were also installed on the lower and upper splice plates (SG3/SG4 on the RH splice plates, SG9/SG10 on the LH splice plates). Additional strain gauges were placed on the upper and lower flanges of the original longeron just aft of the splice plates (SG5/SG6 on the RH longeron, SG11/12 on the LH longeron). A data acquisition system was built and programmed for collecting sensor and strain gauge data during the fatigue test. A load controller was also programmed, calibrated, and tested to insure that correct load levels were introduced into the fuselage article during fatigue testing. Figure 23 is a photograph of the test article mounted in the fixture, the MsS damage sensor acquisition unit, and the data acquisition hardware (shown from right to left).

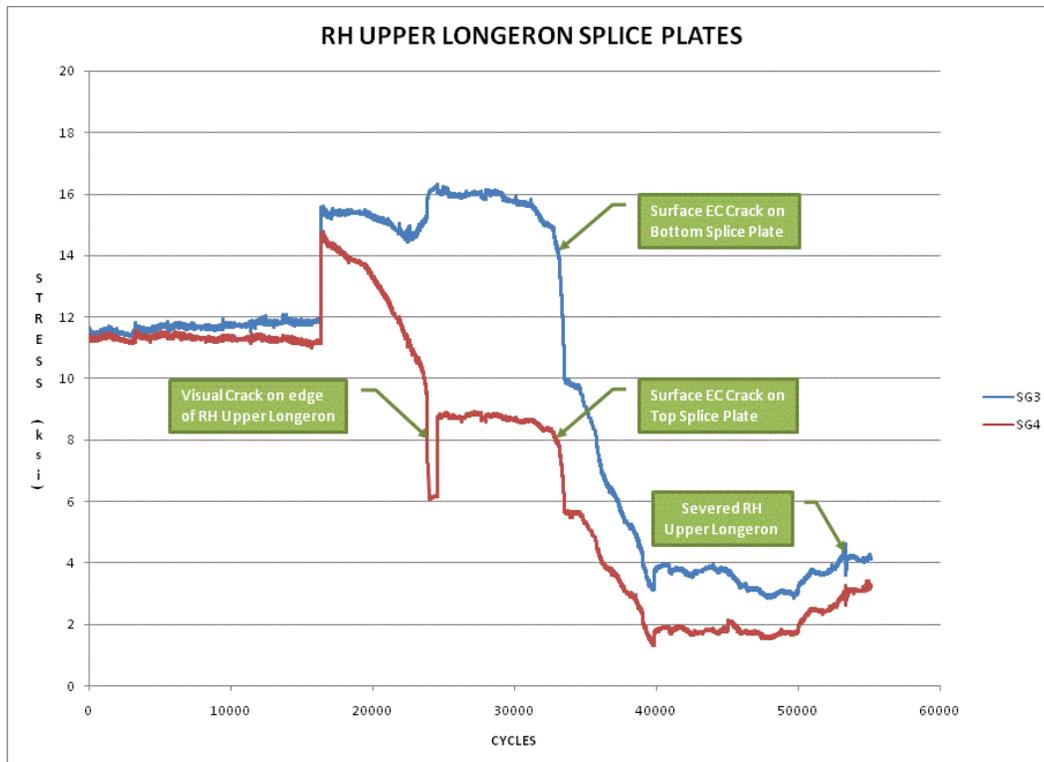
Figure 24: Loads Monitoring of Splice Plates on RH Upper Longeron

amplitude command load level of 12-ksi for 16,340 cycles. Then, the load level was increased to 15-ksi, and during the loads monitoring, researchers noticed stress levels dropping off dramatically in the upper splice plate on the RH upper longeron (Fig. 24, SG4) while the stress level increased on the lower splice plate (Fig. 24, SG3). During these changes in stress levels, a crack was found visually in the flange of the RH upper longeron at the aft end of the splice plates. The crack was located at the fourth critical location identified in Project Task 1, but not initially monitored with MsS sensors. At 32,680 cycles, surface eddy current scans identified cracks in both the upper and lower splice plates on the RH upper longeron. As the fatigue test continued, stress levels increased in the RH upper longeron itself just aft of the splice plates (Fig 25, SG5/6) while the stress levels continued to drop off in the upper and lower splice plates on the RH upper longeron (Fig 24, SG3/4). Eventually, the stress levels in the RH upper longeron (Fig. 25, SG5/6) dropped off dramatically, and the RH upper longeron severed at 54,542 cycles. The test article continued to carry load after the RH upper longeron severed, but the fatigue test was halted at 55,100 cycles in order to conduct a teardown examination of the test article with the known fatigue failures.

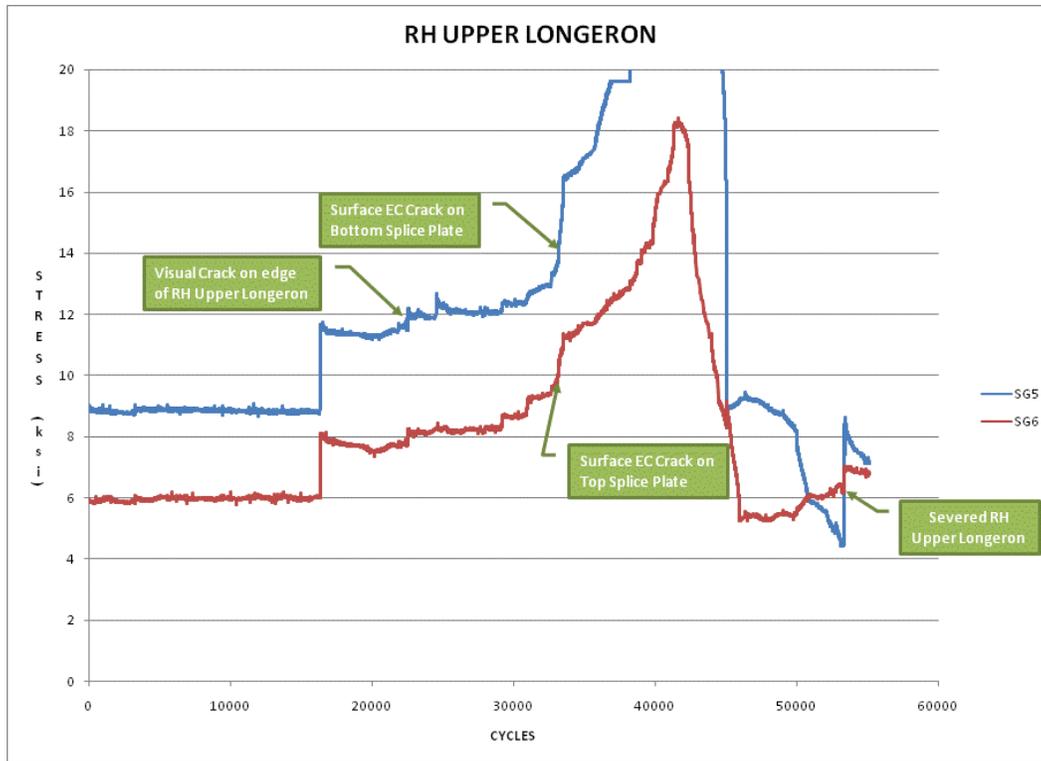
Figure 25: Loads Monitoring of RH Upper Longeron

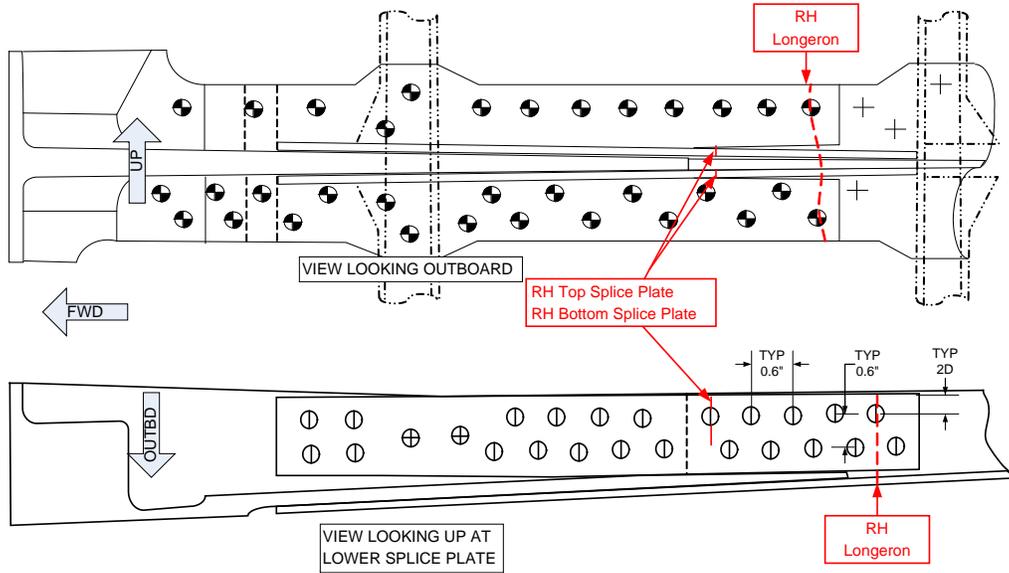
Figure 26: Fatigue Crack Locations in RH Upper Longeron

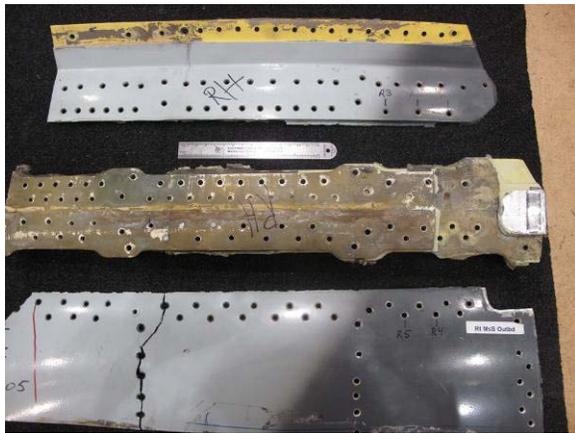
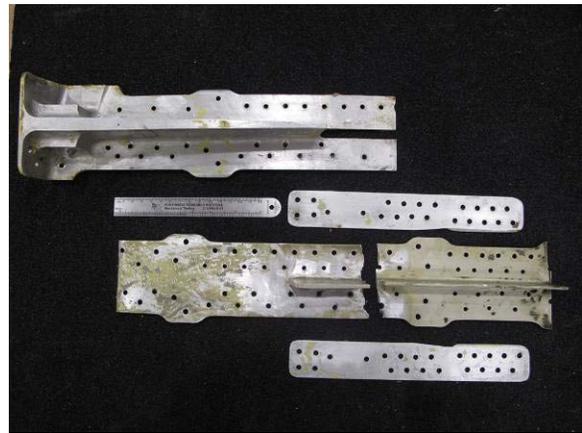
a) Extraction

b) Disassembly

Figure 27: Extraction and Disassembly of RH Upper Longeron

The RH upper longeron was extracted from the test article, as photographed in Figure 27(a), and further disassembled for examination, as photographed in Figure 27(b). Optical stereomicroscopy and scanning electron microscopy examinations were conducted on three fractures, which are photographed in Figure 28. Fracture #1 is the one fracture that nucleated in the original RH upper longeron at the aft end fastener common with the splice plates (#1A) and propagated through three other fastener locations (#1B, #1C, and #1D) prior to severing the RH upper longeron. Fastener location 1C, which cannot be seen in the photograph, is located in the upper flange of the RH upper longeron just above the leg of the longeron T-section. Fracture #2 is in the lower splice plate, and Fracture #3 is in the upper splice plate. As photographed in the close-up views in Figure 29, both of these fractures propagated from the inboard fastener location just aft of the splice to the inboard edge of the splice plate.

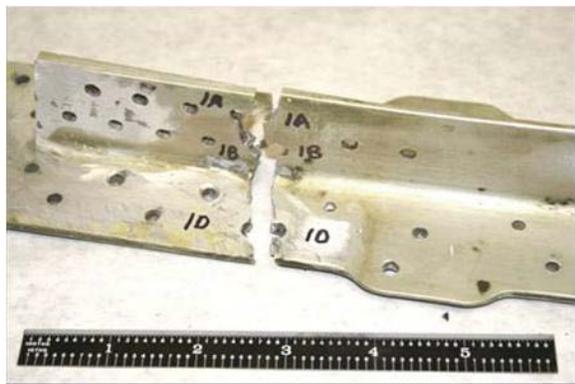
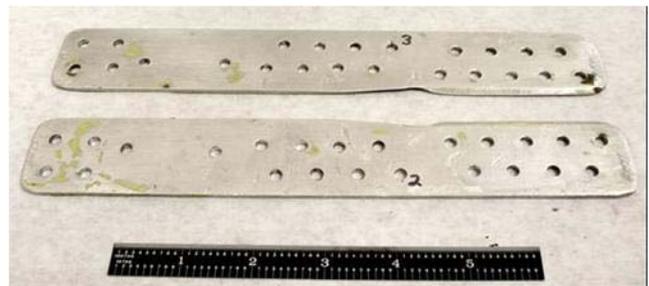
a) Fracture #1

b) Fractures #2 and #3

Figure 28: Fractures in RH Upper Longeron

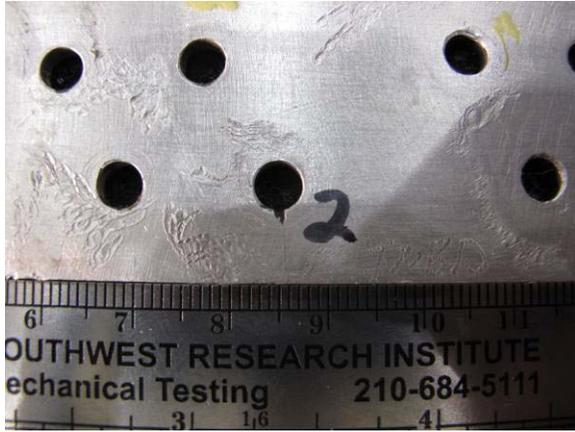
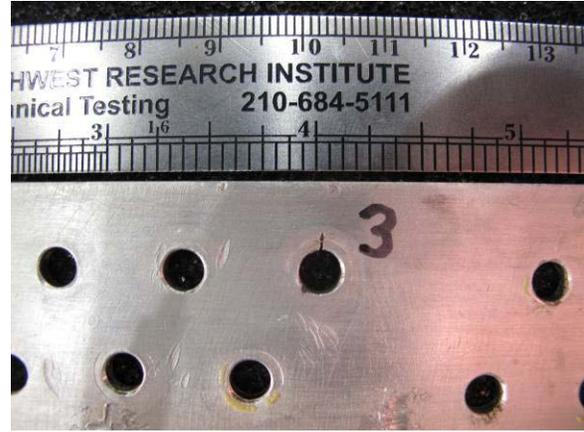
a) Fracture #2

b) Fracture #3

Figure 29: Close-up Photographs of Fractures #2 and #3

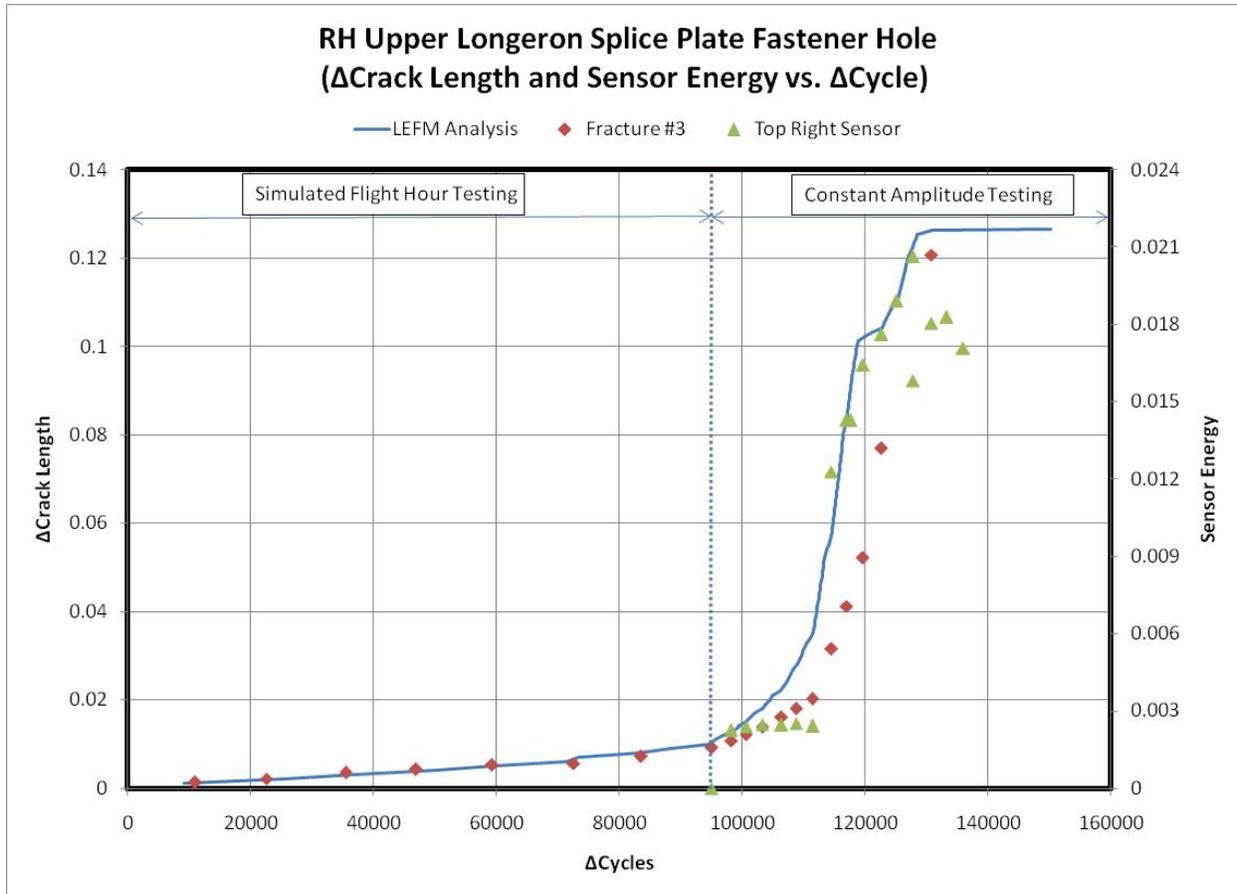
Figure 30: Correlation of Analysis, Fracture, and Sensor Data

The one location where all the pieces needed for calibrating the damage sensor system were present (sensor readings and fracture data along with a fracture mechanics model) was the upper splice plate on the RH upper longeron (Fracture #3). Therefore, sensor data and fatigue test results were correlated for this location. With this data correlation, researchers were able to establish a minimum detectable level for the MsS sensor monitoring of the upper longeron splice plate and determine the relationship between the sensor magnitude readings and flaw size. Figure 30 shows the correlation of crack growth analysis, fracture data, and sensor readings with cycle counts from the fatigue test.
