Integration of Remote Sensing and Risk Analysis for Airframe Structural Integrity Assessment

D. Cope¹, J. Cronenberger¹, K. Kozak¹, K. Schrader¹,
L. Smith¹, and C. Thwing¹

¹ Southwest Research Institute, San Antonio, Texas, 78238, USA

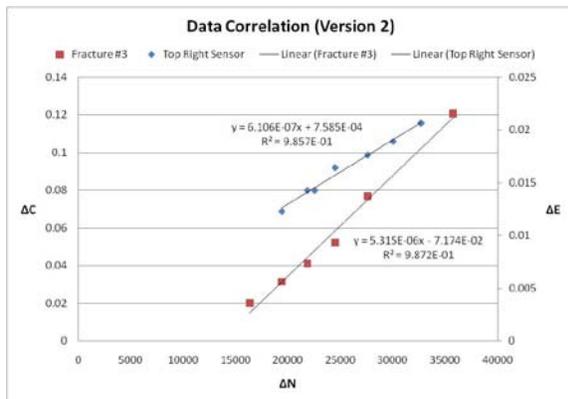
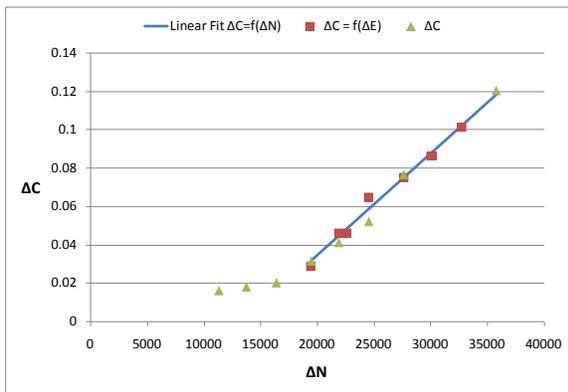
a) Linear Fit of Sensor and Fracture Data

b) Relationship between Sensor and Flaw Size

Figure 31: Correlation of Sensor Magnitude with Flaw Size

used to estimate the flaw size distribution based on sensor readings. It is then combined with the predictions equivalent using the Bayesian updating algorithm discussed previously in Section 4 of this paper. Bayesian principles were applied in order to determine a weighted average flaw size distribution based on both analysis and sensor data. The weighted average flaw size distribution was then used to provide an improved estimate of the remaining useful life and probability of structural failure for the critical component. For the specific case of the RH upper longeron splice plate, correlation of the analysis and sensor data indicated that the minimum detectable level of crack growth was 0.045-inch with an average difference of 0.020-inch. Once crack growth exceeded the minimum detectable level, the accuracy of the sensor readings to estimate flaw size improved to an average difference of only 0.0055-inch. This improved accuracy is illustrated in Figure 31(b), showing how flaw sizes estimated based on sensor readings ($\Delta C = f(\Delta E)$) match up with fracture data (ΔC) and the linear fit of fracture data with cycle counts ($\Delta C = f(\Delta N)$).
