Health assessment of traction-motor blowers regarding their deformation degradation

ABSTRACT

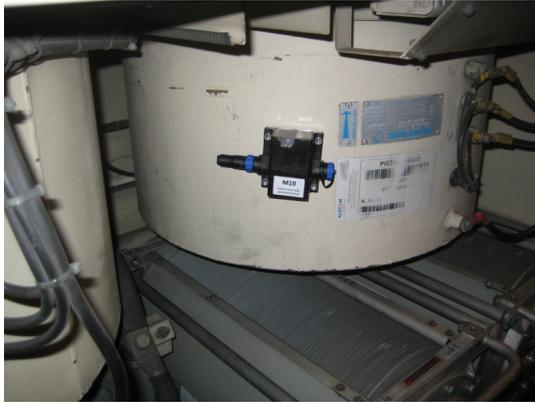
Figure 2. TheMotes installed on the outer casing of the traction-motor blower.

lowed in order to approach the predictive maintenance in an ordered manner, first extracting the signal features, and then deploying models to conduct the diagnostics and the prognostics. We will particularly focus our efforts on the detection and management of the turbine deformation, because this is not being properly addressed by the current maintenance approach. In order to do so, the vibration of the blowers in operation will be acquired with a network of intelligent wireless sensors called TheMotes (A. Trilla and P. Gratacòs,2013), see Figure 2. Vibration is a very rich proxy variable that encodes lots of information and denotes the presence and condition state of rotating mechanical components. TheMotes were chosen because they are non-intrusive (magnetically attached to the outer casing), do not require cabling (data is forwarded wirelessly from device to device and finally collected with a tablet), do not interfere with the operation of the system and are ideal for retrofitting. They acquire a vibration signal with 3 axes, during 10 seconds, and with a sampling rate of 3.2kHz using an on-board Micro-Electro Mechanical System-based sensor.

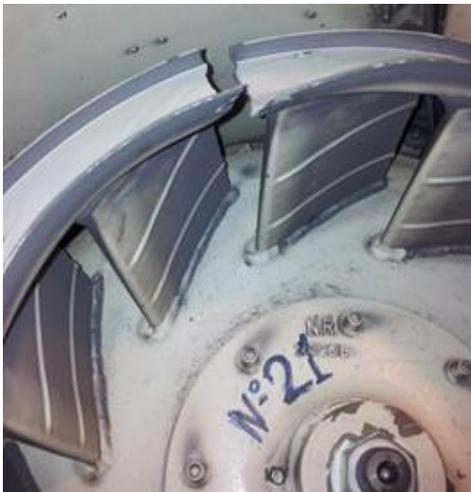
Figure 4. Service-affecting failure of a traction-motor blower. Note how the turbine has been heavily deformed before breaking.

Note that many of the indicator values for these failing traction-motor blowers have been masked by the overall behaviour of the fleet, i.e., they don’t show significantly anomalous values, except for blower 01-01-01. It is possible that the service-affecting failure develops so fast that its signature could not be acquired during the monitoring of the sample. Figure 4 shows an example of such catastrophic failures.
