# Case Study: Vibration trip and post-event Analysis with Auto-Associative Neural Networks on a Large Steam Turbine.

Luc Fromaigeat<sup>1</sup> and Gianluca Nicchiotti<sup>2</sup>

<sup>1,2</sup>*Meggitt Sensing Systems, Fribourg, CH-1701, Switzerland*

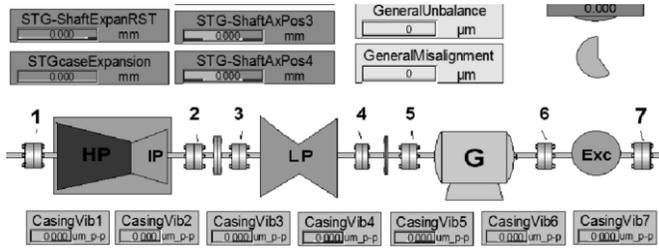
Figure 2. Main Steam Turbine Generator with arrangements of HP, IP, LP turbine bodies and bearings (extract from an on-line mimic).

This coal-fired power plant (Figure 1) located in India, has two 300 MW units, each unit is based on a steam turbine-generator (STG) equipped with 7 bearings and running at 3000 RPM (Figure 2).

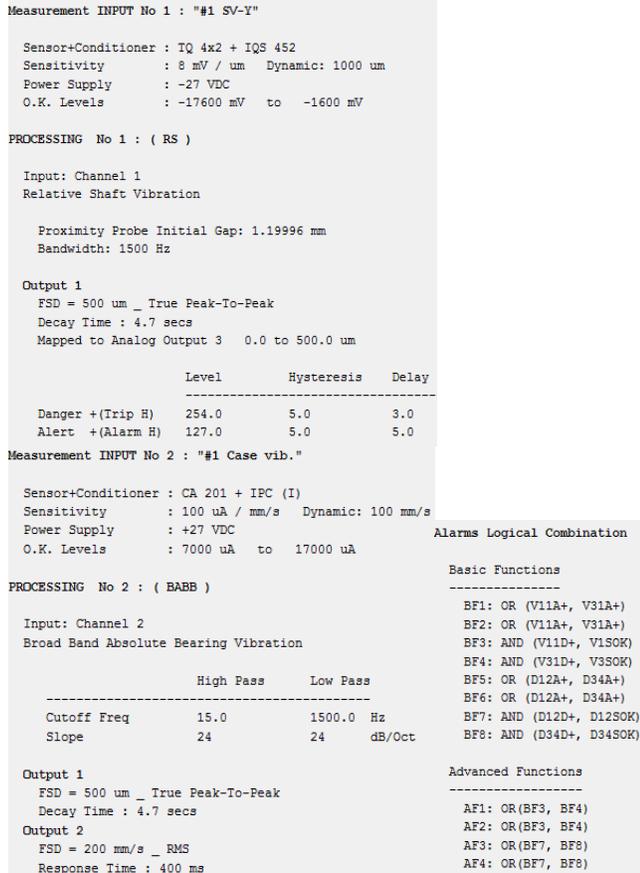
Figure 3. Vibration configuration for protection: Relative shaft channel (left), Absolute bearing channel (middle) and logical combination for the trip logic sent to relays.

These are some of the parameters (Figure 3), configured in the system, which were used, therefore recommended for this type of large Steam Turbine protection (extracted from the Configuration Summary).

Interesting parameters involved are: the filter allows up to 1500 Hz, this as per §5.2.3 in (ISO-comitee, ISO 10817-1, 1998). The delay is 3 seconds. All decision are routed to 2 redundant relays, and the trip signal, at 254 micrometers Peak-to-Peak is validated by the [ok] of each channel. The threshold is a little bit higher than in (ISO-comitee, ISO 10817-1, 1998). This achieves both a good reactivity in case of a real trip event, as well as rejection of false events due to, for example, a failure at the sensor or at its connection to the system.

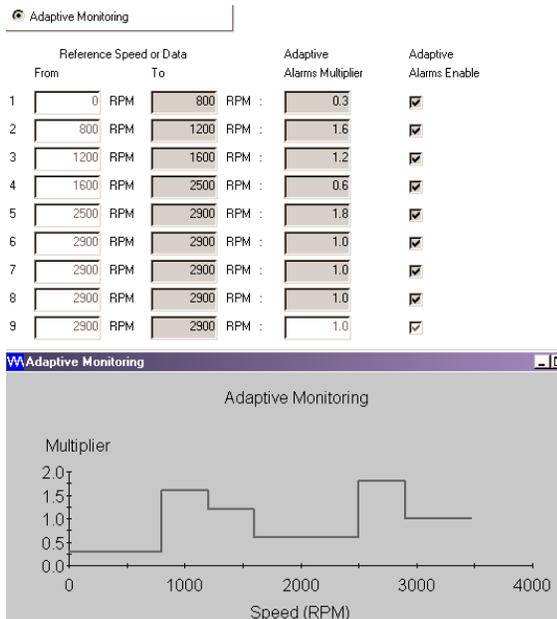
Figure 4. Example of adaptive monitoring configuration for critical speeds (shaft resonances) allowances, applied to the the threshold.

At some bearings, critical speeds generated trip during run-ups. Adaptive monitoring (Figure 4) is used, then to allow passing, indeed rapidly, these critical speeds to reach nominal speed. This is an improvement to the “Trip Multiply” method, for which the multiplier on the threshold is unique across all speed layers. This “Adaptive Monitoring” is one of the features participating to improve the accuracy of the protection. The adaptive does not affect the protection at normal operation at 3000 RPM.

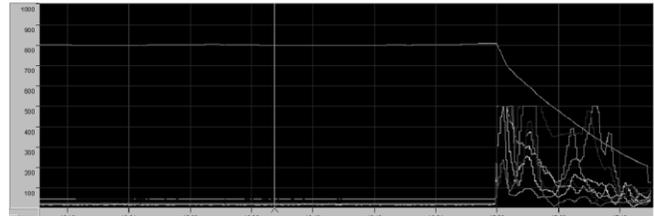
The background level before the trip is approx. 25  $\mu\text{m}_{\text{Pk-Pk}}$  on an average, and always less than 50  $\mu\text{m}_{\text{Pk-Pk}}$ . The vibration levels jumped suddenly by a factor of 10, at least.

Figure 5. Vibration Trip, as recorded in the DCS during one hour before machine stop at 17 h00.

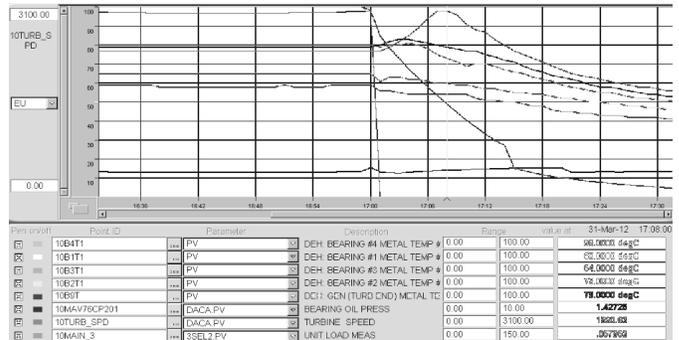
Other parameters were affected: in particular bearing temperature rose on bearing 4 (Figure 6), but the maximum was reached only 9 minutes after the trip.

Figure 6. Other parameters during the trip. The maximum temperature is on bearing 4 and 9 minutes after the trip.

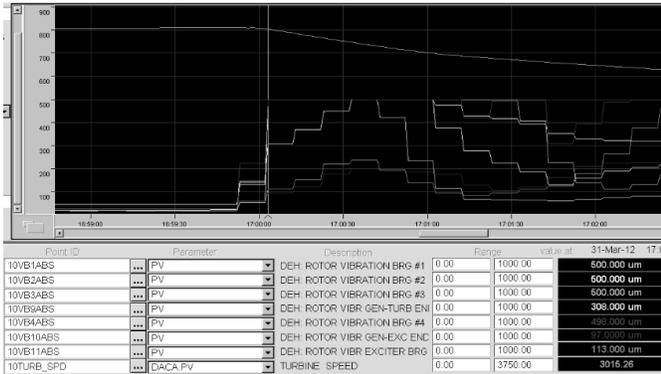
But not all bearings were involved in the incipient change. We observed that bearing 4, then 3, surrounding the LP turbine, responded first to the incident. This confirmed the "First-out-Event" in the Protection System.

Figure 7. Incipient change of vibration levels: bearing 4 increases the most and the fastest in the first 10 seconds before reaching maximum level. The cursor is on the event.

We could confirm this, after looking at the vibration data recorded in the CMS. Our recommendation then followed: to open LP turbine body on the side of bearing 4.

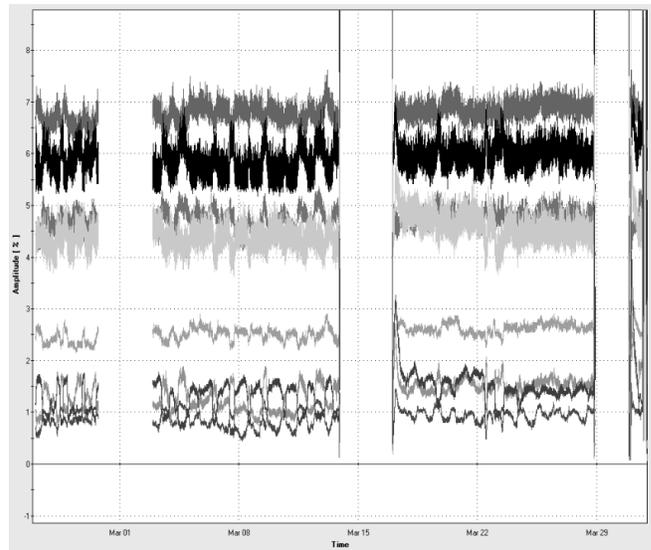
There was no sign in the trends, whatsoever, that could indicate the failure before it occurred. This is well known in literature (McCloskey, 2002) that a sudden blade failure can well happen without any preliminary change on vibration parameters. Within 2 years of operation, the machine showed same vibration behavior with thermal transients after run-ups, and some fluctuations with load and daily temperature changes (Figure 9).

Figure 9. Vibration trends observed one month before the event, on bearings x extraction {3,4}x{Overall,(1X)}. Normal fluctuations are due to daily load and temperature changes.

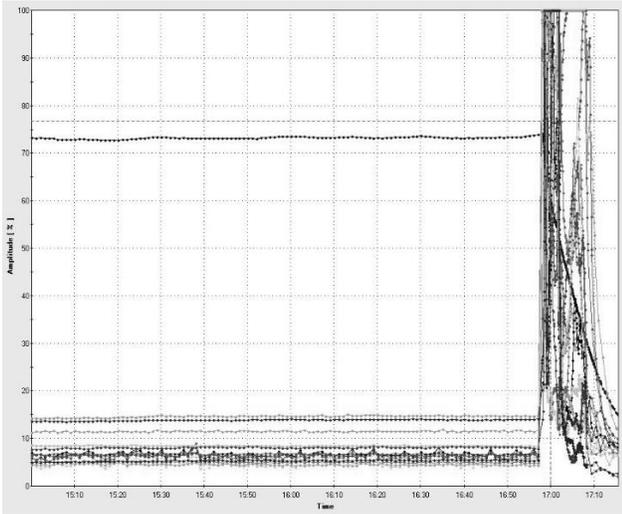
All vibration bands and gap show the same flat curve a few hours before the trip. From Figure 10 it is possible to observe that after the trip none of the sensors give less vibration than the maximum observed before.

Figure 10. Vibration trends 2 hours before the failure.

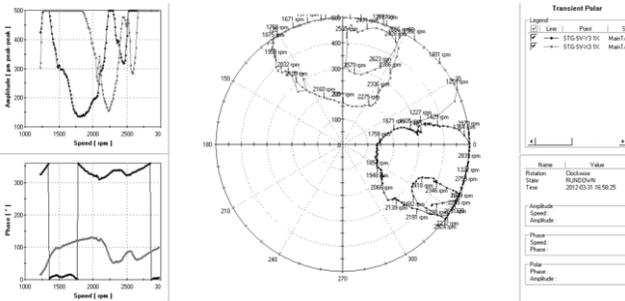
The response is much bigger (over 500 μm\_pk-pk), compared to previous transients, and this strong (1X) means “unbalance” as per general diagnostic rules.

Polar, Bode, Cascade for all bearings and directions were plotted. They are not all presented here. On bearing 3 and 4, the rundown signature is way-off the normal behavior of the shaft.

Figure 11. Example of Polar plot on bearing 3.

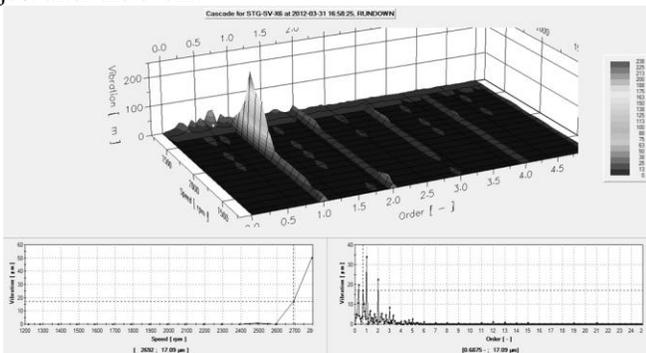
But, we can still make use of the signal that were not saturated. This is the case for bearing 6 signals, even just after the trip. Bearing 6 is located on the other side of the generator. In this signature there is a strange subtle change that had never been seen before on this machine. It consists of additional  $1/3$ ,  $2/3$ ,  $1+1/3$ ,  $1+2/3$ , etc. signatures in the spectra (Figure 12) and can be seen almost on all bearings just after the event.

Figure 12. Valid cascade plot on a non-saturating sensor. Strange inter-harmonics can be seen in the early stage of the rundown (details are on the spectrum, left-bottom).

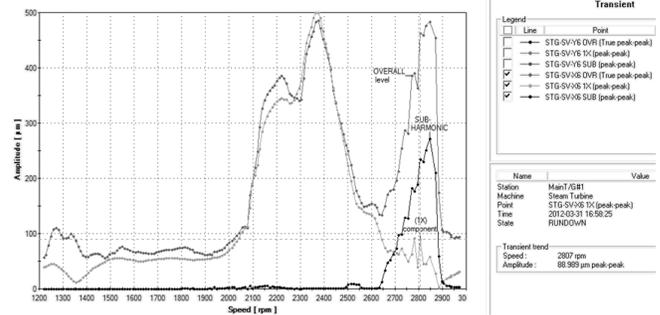
In this early stage, the sub-harmonics represent a large part of the signal, as shown in Figure 13. They mostly consist in this  $1/3$  harmonic and multiples.

We think these inter-harmonics, both sub- and higher -harmonics signatures, at fractional ratio of harmonics, can be related to a well known effect due to “Erratic loose parts” in rotating machines. This type of signature is known to be due to non-linear, chaotic movements of lost parts inside a rotor, rotating within a certain specific range of speed, which depends on the weight of the part.

Figure 13. Transient (rundown) trend of the bands: Overall, 1X, and sub-synchronous. Between 2900 and 2700 RPM, the SUB harmonics is abnormally high.

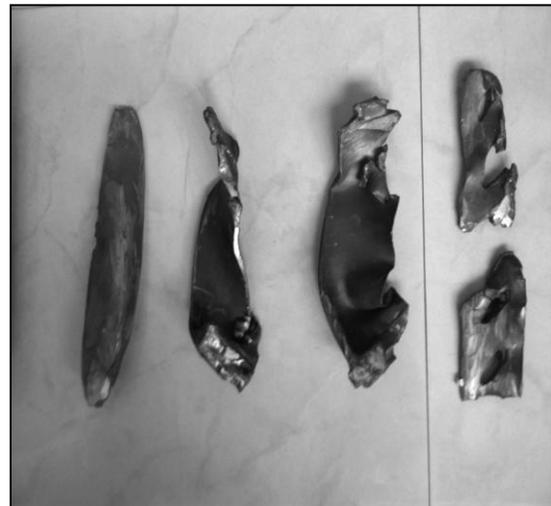
When opening the machine, 2 blades were discovered inside the LP body. Eventually a total of 4 blades were detached from the rotor (Figure 14).

Figure 14. Rests of blades found in LP turbine after the trip.

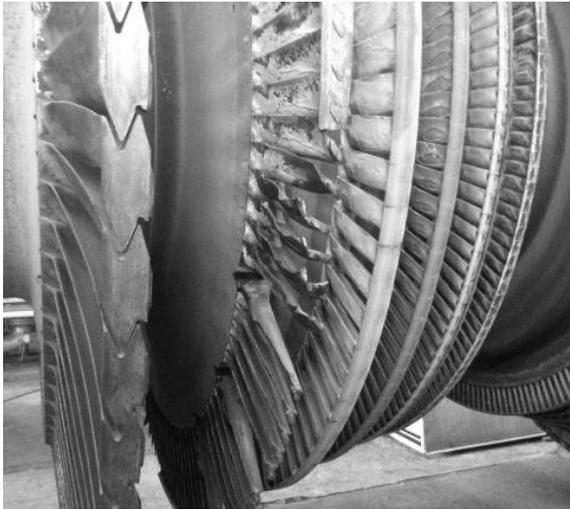
The rotor showed the 4 missing slots on disk #5, out of the 7 disks. Most blades have been de-rooted from the shaft (Figure 15), shrouds being gone.

There is almost a periodicity of 6 in the blade loss. This is because, on this side, blades are attached by groups of 6 to the same shroud. Also 2 fixed blades were off in the stage between 5 and 6. We believe these were a consequence of rotating blades loss, because they could have been hit by the “flying” blades, downstream the steam path afterwards.

Figure 15. Rotor showing missing shrouds and 4 blades off, at positions: 7, 13, 19, 38 on stage 5 that has a total of 124 blades. On this side, 2 blades had been de-rooted.

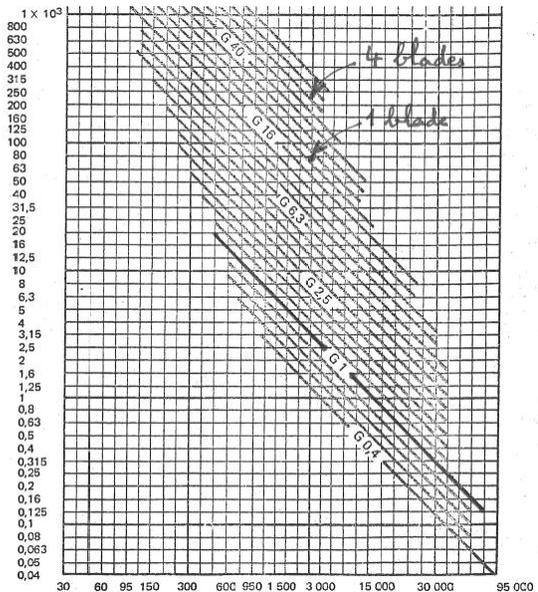
Figure 16. Static Unbalance calculation with removal of 1 blade, then 4 blades, on x-axis: speed in RPM (on graphic from ISO 1940-1)

In terms of balancing standards, the initial turbine could be specified G2.5, was actually G6.3, and the loss of 4 blades moves it to G63, which is a considerable value of unbalance to consider at this nominal speed (3000 RPM).

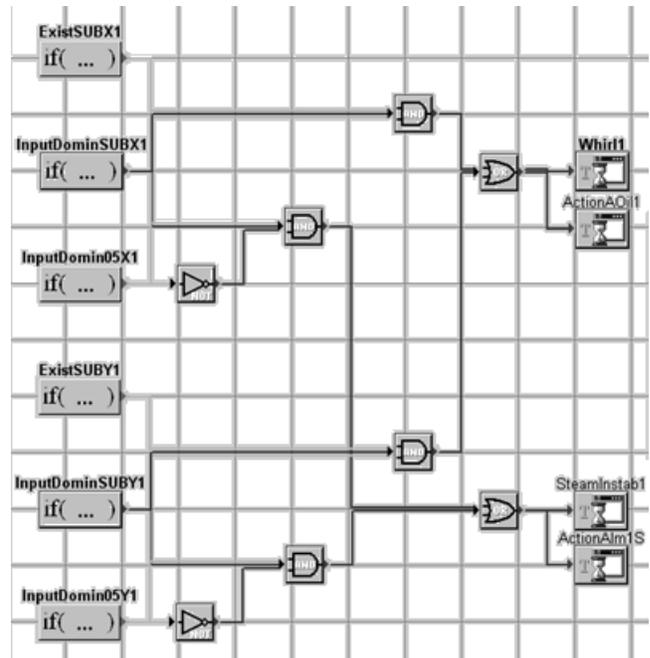
- fluid dynamic instability of steam, whose signature is a strong sub-synchronous, but rarely restricted to 0.5X only,
- oil whirl in the journal bearing, indeed a quite different defect, always located between 0.43X and 0.48X, so that all its energy, using the FFT configured resolution, is located in the 0.5X band.

Figure 17. Example of rule for Oil-whirl and Steam instability with tests (at left), operations (in middle) and actions (at right).

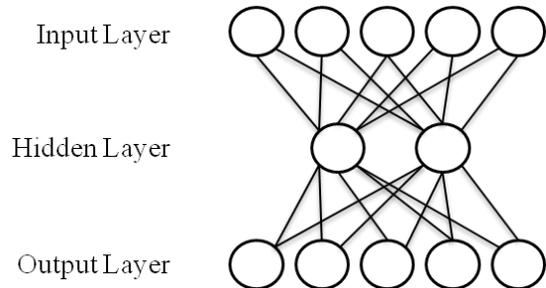
At first sight, this replication task could seem trivial; however, the network structure has a “bottleneck” as the hidden layer has fewer neurons than the input and output layers as it can be observed in Figure 18.

Figure 18. A simple Auto-Associative Neural Network.

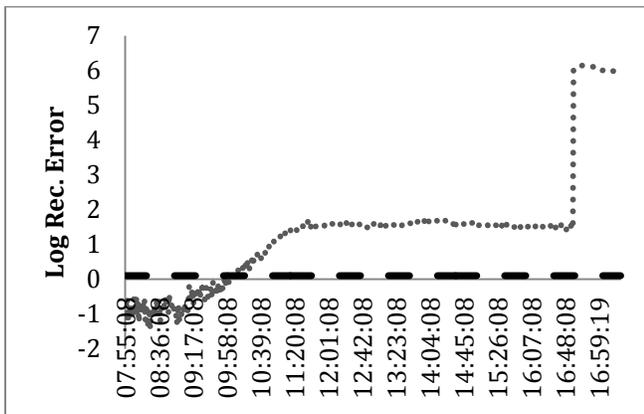
Figure 19. Reconstruction error in Log10 scale. Dashed line represents the threshold level, dotted line the Log10 of RE.

It is fairly visible from both plots that RE starts increasing just before 10 am. On the logarithmic plot our statistical threshold level (dashed line) is crossed before 10 am. Then a plateau is reached just after 11 am and this level is maintained until the trip event.

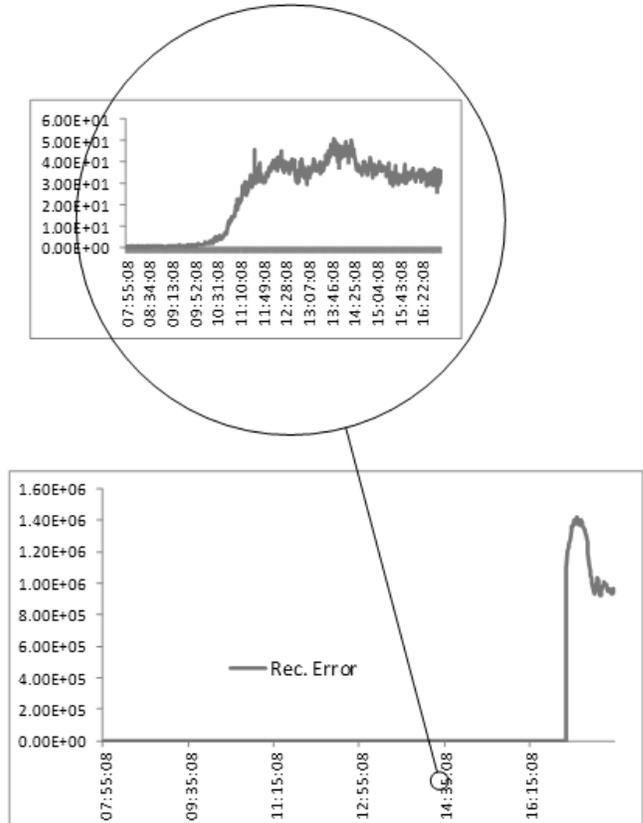
Once training has been completed data acquired during the last ten hours before the incident has been processed by the network. For each sample the reconstruction error using  $L^2$  norm has been computed. The results, plotted in linear and log10 scale, are shown in Figure 20

Figure 20. Reconstruction error in linear scale, on top the zoom of the period before the incident
