Experimental assessment of a broadband vibration and acoustic emission sensor for rotorcraft transmission monitoring

Cristobal Ruiz-Carcel¹, Andrew Starr¹, and Arturo Francese¹

¹ *Cranfield University, Cranfield, Bedfordshire MK430AL, United Kingdom*

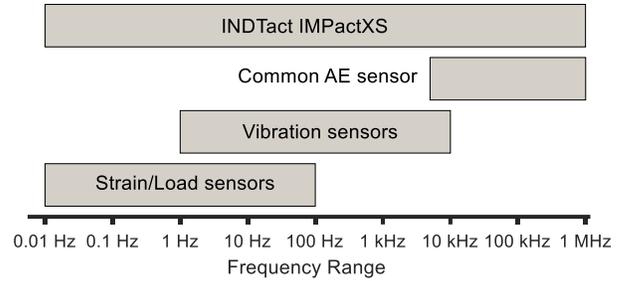
Figure 1: Typical frequency band of different sensors (iNDTact GmbH, 2022)

The iMPactXS high-performance acoustic emission and dynamic load sensor manufactured by iNDTact GmbH was selected due to its frequency range (0.1 Hz to 1MHz) and sensitivity (> 1200 pC/N). As shown in Figure 1, this sensor covers the typical frequency ranges of both, vibration and AE sensors. The sensors were connected to an iNDTact champ charge amplifier, and the signals were digitized at 2 MHz

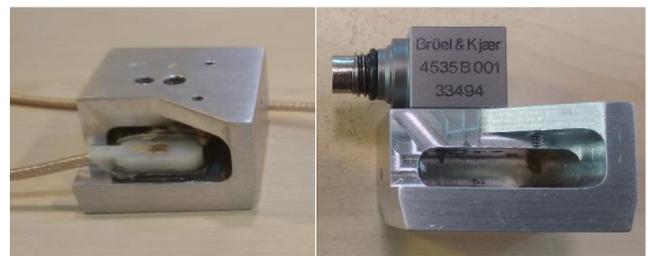
Figure 2: Sensor cluster detail

In order to ensure that the transmission path for both sensors is equivalent a special sensor cluster was designed. Both sensors were installed in a compact machined aluminum block as shown in Figure 2. The AE sensor was glued using Dow Corning 3140 as a wave couplant, whereas the AE sensor was bolted to the metal block with an M3 stud. The cluster was attached to the rig using Loctite EA 9492.

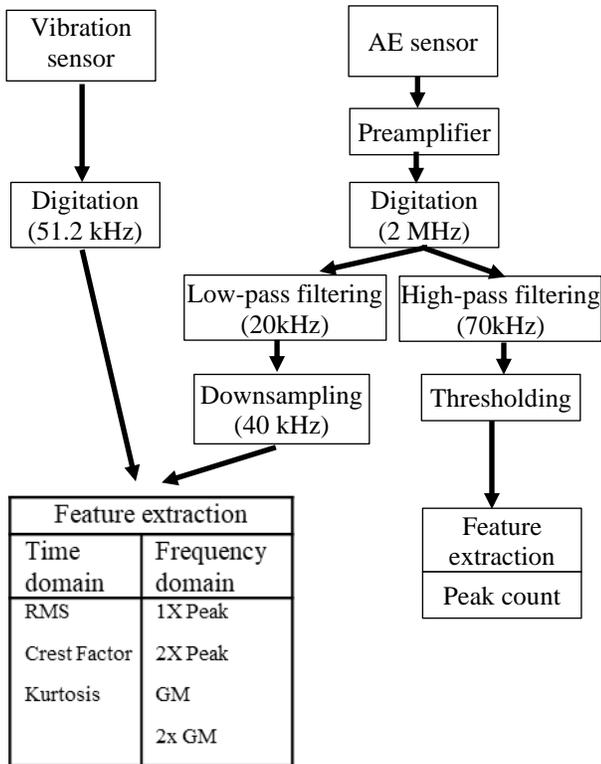
Figure 3: Data analysis workflow

The signal processing strategy used for both sensors is represented in the diagram in Figure 3. Once digitized the vibration signals are processed directly for feature extraction. The AE signals however, after preamplification and digitation are divided in two categories using digital low and high pass filters with a cut-off frequency of 20 and 70 kHz respectively. Such approach allows for individual analysis of “low frequency” vibration-like events (such as oscillations

related to misalignment, unbalance, gear mesh, bearing faults or resonances) independently from “high frequency” events such as impacts, friction or crack growth. The low frequency part of the signal is then down sampled to 40 kHz, which is enough to accurately represent the vibration signature and reduces computational cost. The features extracted from vibration signals in the time domain are RMS, crest factor and Kurtosis. The frequency spectrum is obtained using the FFT, and the peak amplitudes at the input shaft frequency (1X), the second harmonic (2X), the gear mesh frequency (GM) and its harmonic (2xGM) are extracted. This collection of CI’s is equal for both, the vibration sensor and the low frequency part of the broadband sensor. The selected CI’s are basic, well understood and widely used in gear monitoring, making them appropriate for this comparison exercise. The

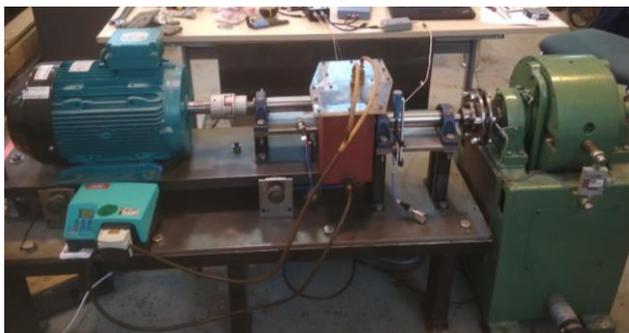
Figure 4: Gearbox rig

The rig used to assess the performance of the sensors is a single stage gearbox rig (Figure 4), powered by an 11kW induction motor with 2 pairs of poles, and a nominal speed of 1490 rpm. The output shaft is connected to a dynamometer that absorbs and measures the load applied. The gear pair has straight teeth, a module of 5, and 24 and 25 teeth in the input and output shafts respectively. A lubrication port on the gearbox casing cover provided lubrication from an external pump. Although this benchtop arrangement is quite different from a helicopter gearbox in terms of shape, size, power, and stiffness, the gear meshing dynamics are the same as in any gear pair. The transmission path for the fault generated forces through the gears, shafts, and bearings to the static components are also comparable. Figure 5 (left) shows a detail of the gear pair. Figure 5 (right) shows the location of the sensor cluster, installed on a flat surface in the vicinity of the input shaft bearing housing.

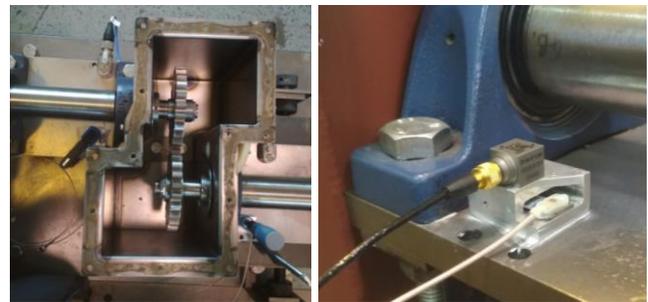
Figure 5: Gear pair (left) and sensor cluster location (right)

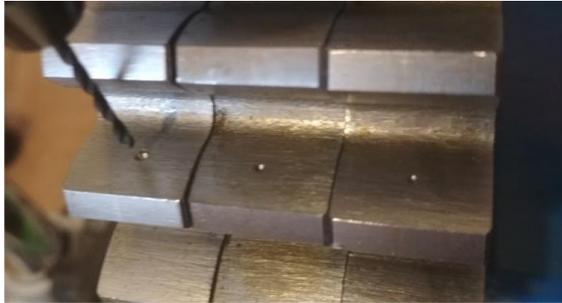
Figure 6: Detail of artificially introduced spalling

induce more deleterious faults, such as spalling and chipping (Huangfu et al., 2022) Three different defect sizes were tested, drilling holes on the gear tooth surface of 0.8 (small), 1 (medium) and 1.5 (large) mm of diameter and around 0.2 mm in depth (Figure 6).

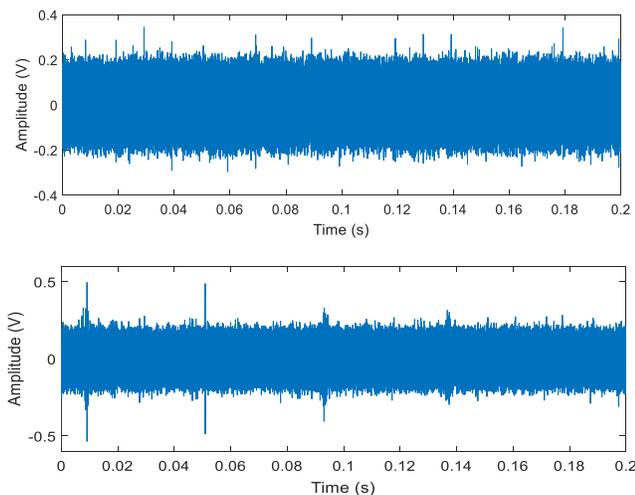
Figure 7: AE signal sample, healthy (top) and small fault (bottom) at 30 Nm

In first place the high-pass filtered broadband sensor signal was observed to assess the capabilities of the broadband sensor to detect small defects. Figure 7 shows a sample of the signals acquired for the healthy case (top) and the small fault (bottom) under 30 Nm of load. The healthy signal is composed basically by background noise, and there are no obvious bursts or peaks in the signal that indicate detection of AE related events. The faulty case however shows a series of bursts that clearly stand out of the carpet level. In addition, the distance between those bursts is around 40 ms, which is the time it takes for a full input shaft rotation to occur. That is the rate at which the induced fault enters the gear mesh.

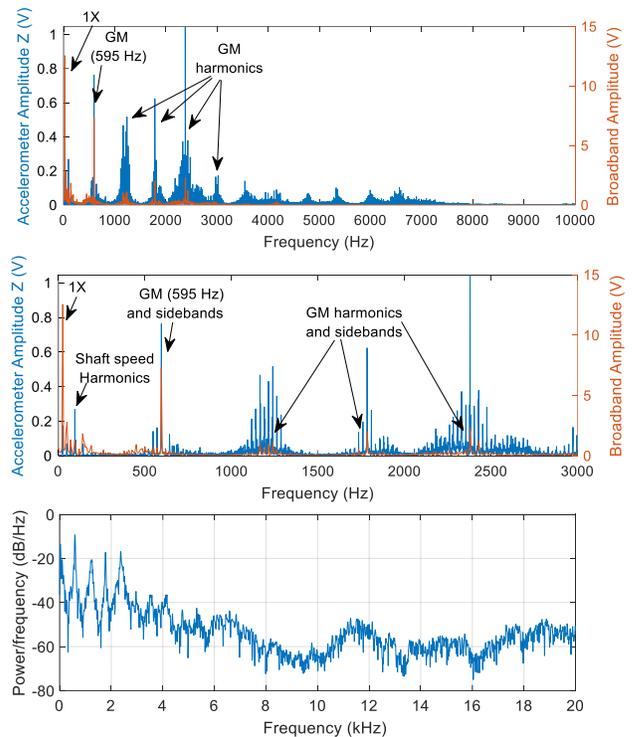
Figure 8: Frequency spectrum of accelerometer and broadband sensor signals up to 10 kHz (top), low frequency detail (centre) and Welch cross power spectral density estimate (bottom)

For the comparison between the accelerometer and the low-frequency part of the broadband sensor, only the Z direction of the accelerometer (perpendicular to the mounting surface) was considered for simplicity, as it is the same direction the broadband sensor is measuring. Figure 8 shows an example of the frequency content from the signal acquired from both sensors in the healthy case and 30 Nm of load. It can be seen that despite the lack of faults the spectrum is dominated by the GM frequency and its harmonics, as usual in gearboxes. The spectrum also shows that these main peaks are surrounded by sidebands, spaced around 24 Hz (the input shaft frequency) from each other. That may be an indication that the alignment between the shafts is not perfect, and the gear mesh is being modulated in amplitude once per revolution.

When comparing the spectrum of both sensors, it can be seen that the frequency content of the broadband sensors is similar to the accelerometer, but the relative amplitude of the peaks differs. It is important to note that the units have been kept in V for both sensors and each one has its own scale, as the potential lack of linearity in the response of the broadband sensor does not allow a direct conversion to acceleration units. The results at the top graph in Figure 8 show that the broadband sensor is able to capture the most relevant components, GM and harmonics, but fails to accurately

capture the amplitude of signal components beyond 3000 Hz. This observation is also corroborated by the Welch cross power spectral density estimate presented in Figure 8 (bottom). This analysis shows the highest coherence between the signals is found below 3 kHz and is particularly high for the GM frequency and its first harmonics. For higher frequencies the coherence is much lower. In principle that is not a huge problem, as the most typical vibration signatures in rotating machinery (shaft speed, GM, bearing defect frequencies, etc. and harmonics of all of them) typically happen in that region. However other important vibration phenomena, particularly resonances, typically happen between 3 and 10 kHz, which could be a problem for this sensor. On the other hand, the AE capabilities should be able to capture impact-like events even earlier than an accelerometer could detect a change in the amplitude of a resonant frequency.

The lack of linearity in the frequency response compared with the accelerometer is quite evident when looking closely at the amplitudes of the main components (Figure 8 centre). Even if the 1X peak amplitude and most of its harmonics are larger than the same peaks in the accelerometer signal spectrum with the selected axes ranges, the correlation is not maintained for higher frequency components (mainly GM, harmonics and sidebands). It can be concluded that the broadband sensor is not as good at responding linearly to a range of different frequencies as the accelerometer. This would be a problem for approaches where it is required to obtain an accurate measurement of acceleration at different frequencies. Commonly that is not the case in monitoring applications, where the typical procedure is to compare newly acquired measurements with a established baseline. From that perspective, repeatability and precision in the representation of amplitude for different frequency components are way more important than accuracy. As it will be seen later, repeatability in measured peak amplitudes was not an issue for this sensor. Despite the lack of fidelity in amplitude compared with the accelerometer, the broadband sensor was able to accurately identify the main frequency components in the signal, which is key to identify the sources of vibration and possible links to mechanical faults. Consequently, the signals acquired from the sensor are in principle adequate and acceptable for monitoring purposes. The next subsection will investigate fault detection performance.

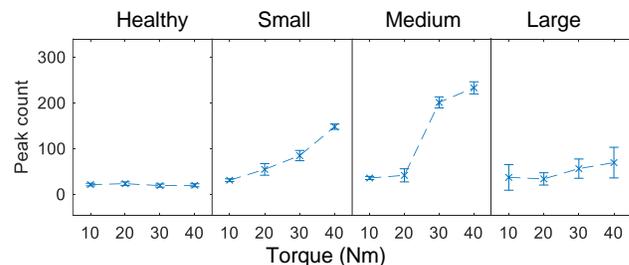
Figure 9: Average value and standard deviation for peak count from AE signal

Presence of peaks in the AE signals for the healthy case should not happen, as only events related to faults produce AE activity. For the faulty cases peak count will depend on rotational speed, defect frequency and whether the amplitude of the AE generate is large enough to cross the threshold. Preliminary analysis of the AE signals obtained under healthy conditions, revealed that the maximum absolute value observed was on average 0.27 V (seen example in Figure 7 top). Consequently the threshold value above that carpet level was set to 0.3 V, which provided the peak counting results shown in Figure 9. As it can be seen, the number of threshold crossings found in the healthy case is small for all loads, and can be attributed to outliers slightly above the threshold level, which was chosen relatively low to enhance sensitivity. The effect of the fault was evident even in the small fault case, particularly for high loads. This result highlights the main benefit of AE and its capability to identify faults in the early stages of degradation. The medium and large fault cases also show larger number of threshold crossings than the healthy case, and the standard deviation in the samples is greater particularly in the large case.

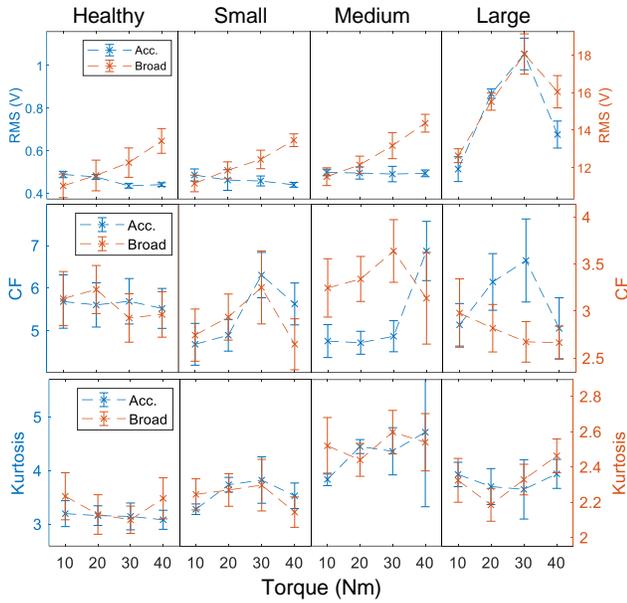
Figure 10: Average value and standard deviation for time domain CI's

Figure 10 shows the results obtained from the time domain vibration CI's extracted from the accelerometer and the broadband sensor. RMS shows little sensitivity to the fault in the small and medium cases, and it was only in the large case that an increment in this indicator was obvious. The case of the CF is not very informative, as the changes in the mean values observed are in the same order of magnitude as the standard deviations. No significant differences with the healthy case are observed. Important to note that the CF is

typically twice as large for the accelerometer than for the broadband sensor, evidencing a larger signal to noise ratio. Kurtosis does not show any evident failure indications for the small case, but the values in the medium case are significantly larger than the healthy case, although they decay again for the large fault case. K values are smaller for the broadband sensor, pointing at a lack of “peakiness” in the signals compared with the accelerometer. It is important to note that despite the differences in magnitude between both sensors for all three indicators, their response to changes in load and presence of faults is similar.

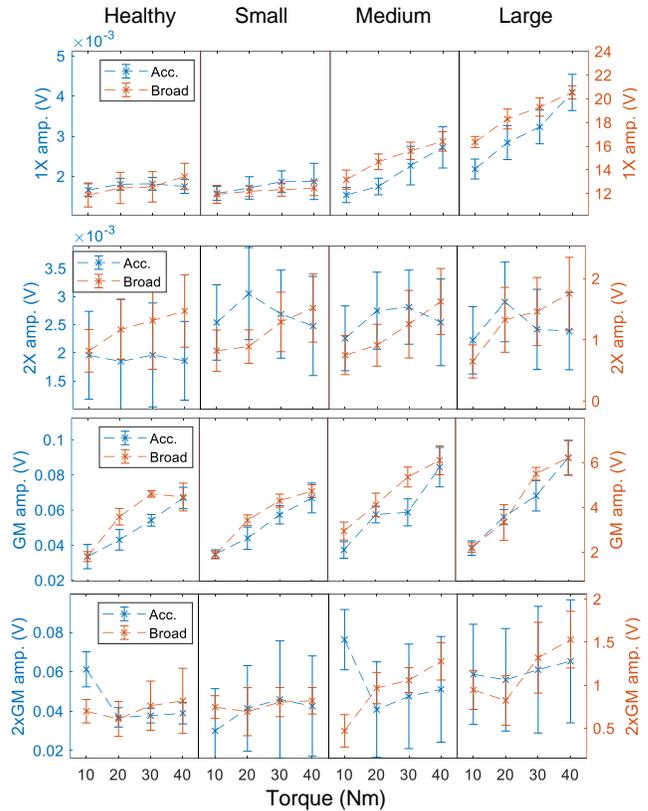
Figure 11: Average value and standard deviation for frequency domain CI's

The results obtained from frequency domain CI's are presented in Figure 11. The amplitude of the shaft speed peak (1X) shows no significant change with the small fault compared with the healthy case. However in both the medium and large cases there is an increment in the CI in both sensors, which is also appreciable as the load increases. The second harmonic of the shaft speed does not present significant changes in the presence of faults for any of the sensors, and any variations are in the same order of magnitude as the standard deviation for the healthy case. The GM peak amplitude shows a small increment for the medium and large faults, but not noticeable increments for the small fault. This CI is clearly correlated with load as well. Its second harmonic shows a very similar behaviour to the 2X case with even greater variability in the accelerometer measurements in the faulty cases. The broadband sensor shows some increment with respect to the healthy case in the medium and large fault cases, but again variability in this CI is too large to consider the differences significant.
