# AI image analysis technologies for efficient water pipeline inspection

Inspection of water pipelines with cameras under pressure is attracting attention. The inspection can be performed without digging the ground and water interruption by inserting a camera into aging water pipes while the water is flowing. However, the inspection has two problems: (1) a long-time visual check by expert engineers is required and (2) variations in the evaluation standards. To solve these problems, we have developed an AI image analysis system for automatically judging the state of degradation of water pipelines by using images captured from the in-pipe endoscope cameras. This report describes the developed technology and software to support the inspection work.

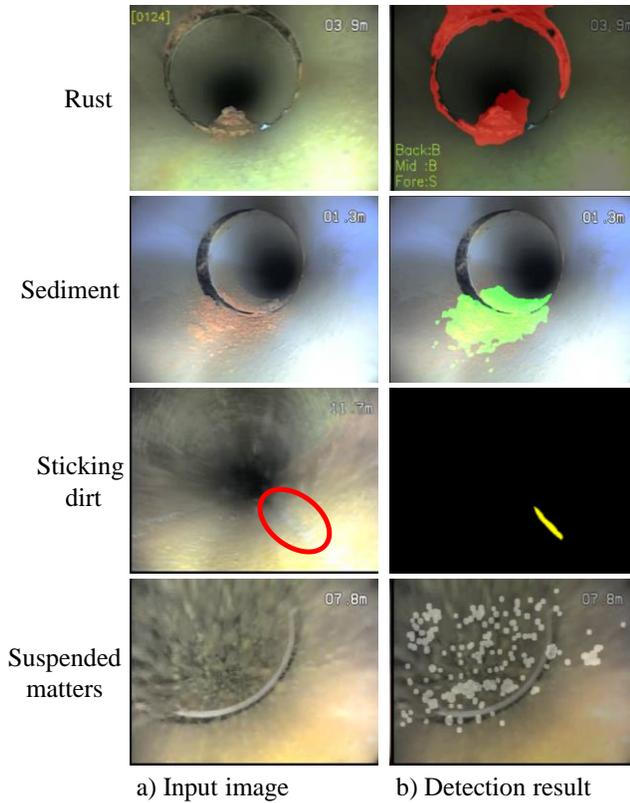
Figure 1. Anomaly detection results

First, using AI-based pixel-by-pixel segmentation and edge detection, the system detects anomaly areas in images captured by in-pipe endoscope camera. Figure 1 shows examples of the detection results of “rust”, “sediment”, “sticking dirt”, and “suspended matters” caused by pipe deterioration. The figures on the left show the input images and the right show the detection results.

Basically, the system uses images when the camera is moving forward, because when the camera is pulled back, deposited sediments, adhesion materials and other impurities are diffused and appear in images more easily. However, in the case of detecting sticking dirt on the pipe inner face, the system uses images when the camera is moving backward to detect the traces (as shown in circle in Figure 1) made by the camera scraping off the pipe inner coating.

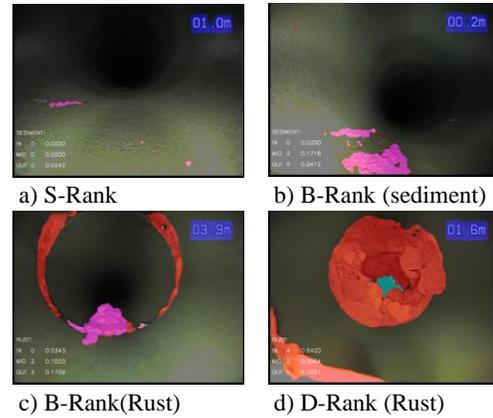
Figure 2. Rank judgement result

As mentioned earlier, a deterioration rank is evaluated based on the diagnostic evaluation standard defined in the guidelines (Japan Water Endoscope Camera Association (2020)). Each item is ranked in the order of S, A, B, C and D, where S denotes the healthy state and D denotes the worst state. These evaluations are based on the size and location of the abnormal area and the structure of the pipeline. Figure 2 a) shows an example of an S-rank image without deterioration, b) shows a B-rank image of a sediment, and c) and d) show examples judged as B and D-rank images of rust.

The blockage rate due to rust on the inner surface of the pipe is cited as one of the evaluation indicators, and this is used to judge the rank of deterioration. The blockage ratio is calculated from the percentage of the detected rust area occupied from the inspection area in the image. The inspection area is pre-specified according to the structure of the pipe. Based on the guidelines, if rust is detected and the blockage rate is less than 30%, it is rank B. On the other hand, if the blockage rate is more than 30%, it is rank D.

sediment area in the bottom of the water pipe. If the occupancy rate of sediment area is less than 30%, it is rank B. On the other hand, if more than 30% of the sediment is detected, it is rank D.

We selected 116 rust images and 142 sediment images with relatively clear detection targets from the three ranks of S, B, and D, which are easy to judge the deterioration ranks. Some of the evaluation images are shown in Figure 2. Experiments were conducted using these images with the proposed method to detect abnormal areas and judge the deterioration ranks.

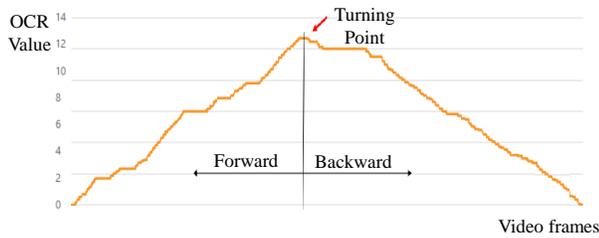
Figure 4. Judge camera motion with OCR

1. Recognize numerical values in an image using OCR as shown in Figure 3 (Numerical values indicating the cable length of the camera, that is, the position of the camera)
2. Judge camera motion (moving/stopped) based on the quantity of change in a sequence of images
3. Set the maximum value recognized by OCR and the point where the image is stationary as the turning point (Figure 4).
4. Set the frames before the turning point as forward and these frames after as backward. After that detect each anomaly area and judge its deterioration rank corresponding to Table 1.

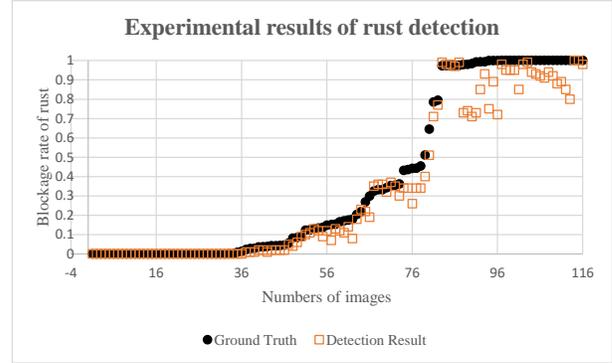
Figure 5. Experimental results of rust detection

First, we describe the experimental results of detecting anomalous areas. The rust blockage rates calculated from ground truths are indicated by black circle marks, and those

calculated from the proposed method are indicated by square marks in Figure 5. Experimental results show that the rust blockage rates calculated from the proposed method are close to those calculated from ground truths.

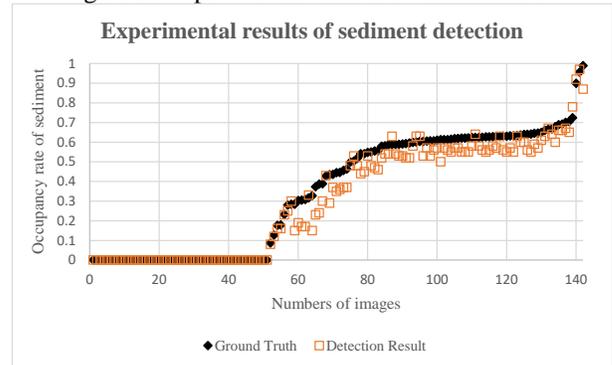
Figure 6. Experimental results of sediment detection

The same method was conducted on the sediment occupancy rate, and the results are shown in Figure 6. The figure shows that the occupancy rates of the sediments calculated from the proposed method are close to those calculated from ground truth.
